Mods 10

10/01/09

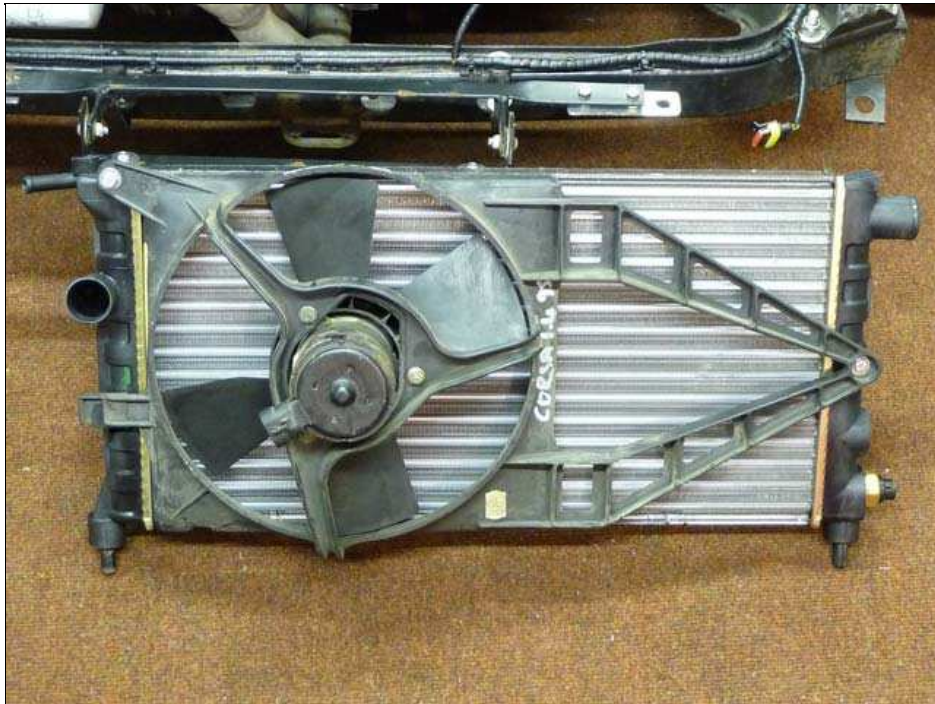
The back of the new rad. I got it from Advanced Autocooling in Keynsham. The fan came from Dean at All Car Spares and the fan switch from Millards. The top mounting pegs on the rad have been cut off - there wasn't room for them.

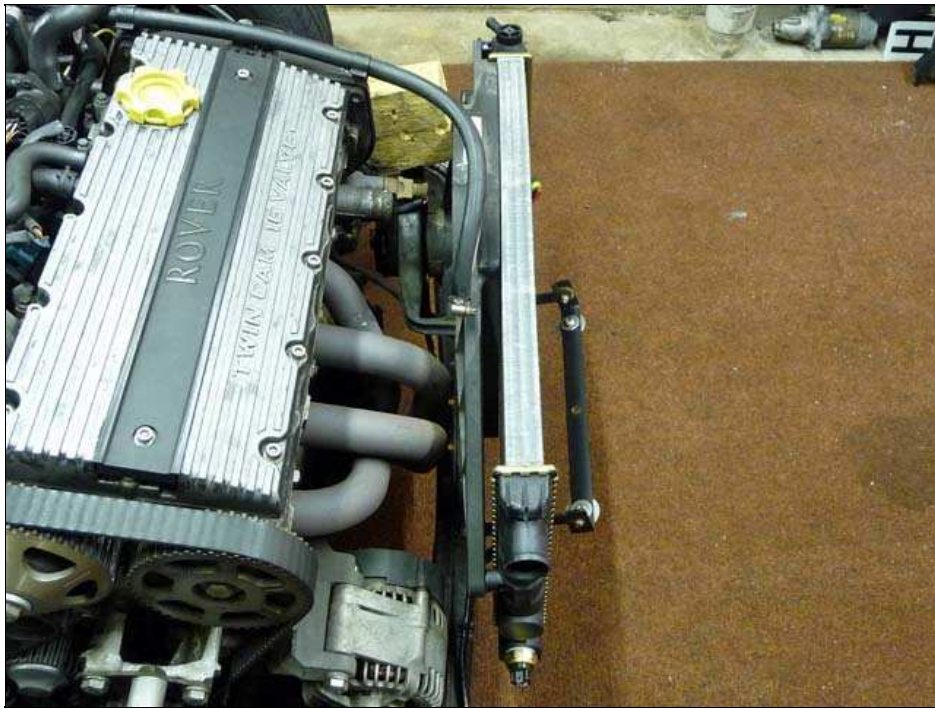
The new rad sitting in place. I've measured everything up and ordered some new hoses, joiners and clips. While I'm waiting for those to arrive, I'll make a start on the VVC swap.

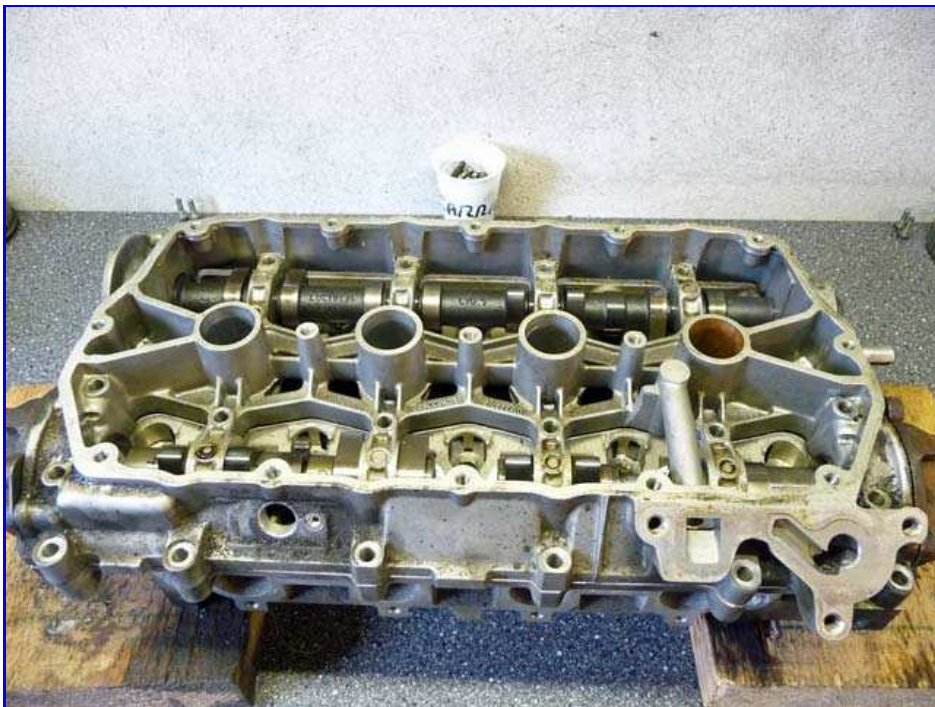
Ken's head on the bench, with the pulleys and all cam carrier bolts removed. The bottom two bolts on each VVC mechanism have been removed and the top two loosened by one turn.

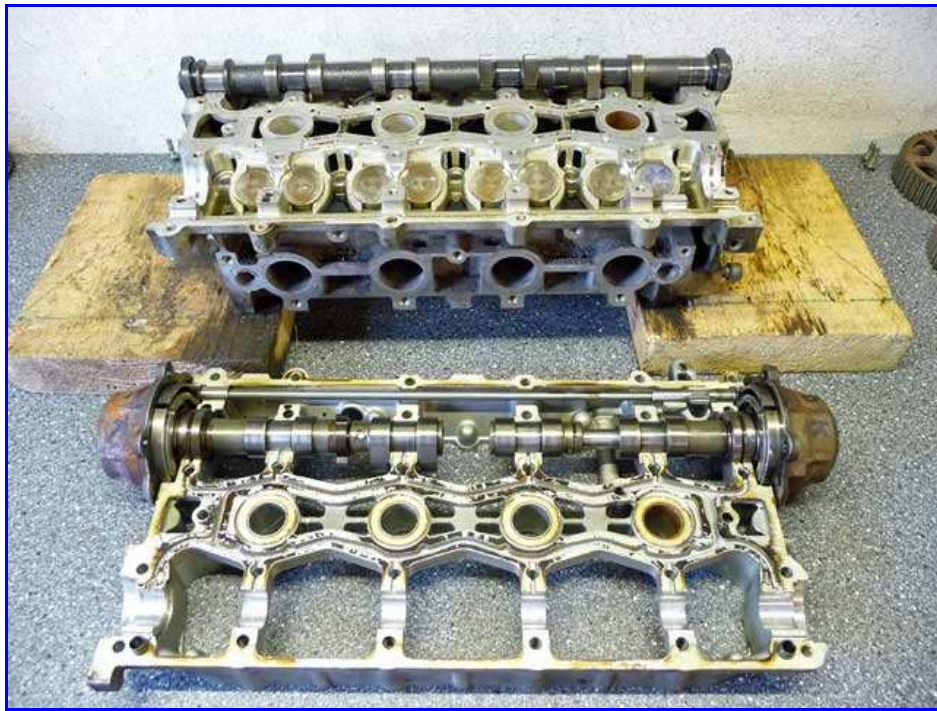
Carefully lifting the cam carrier off leaves the exhaust cam in the head and the VVC mechs and cross-shaft in the carrier.

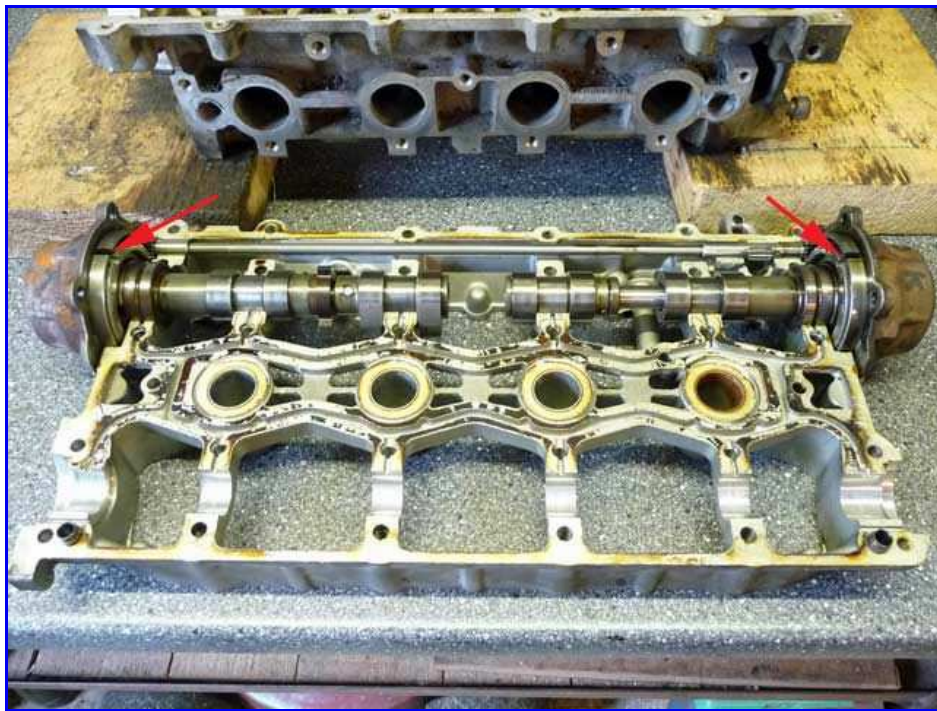
I'll be dismantling the mech on the right in this picture - the one without the ring for the cam sensor. Before starting, the cross-shaft is rotated until the two pairs of timing notches line up.

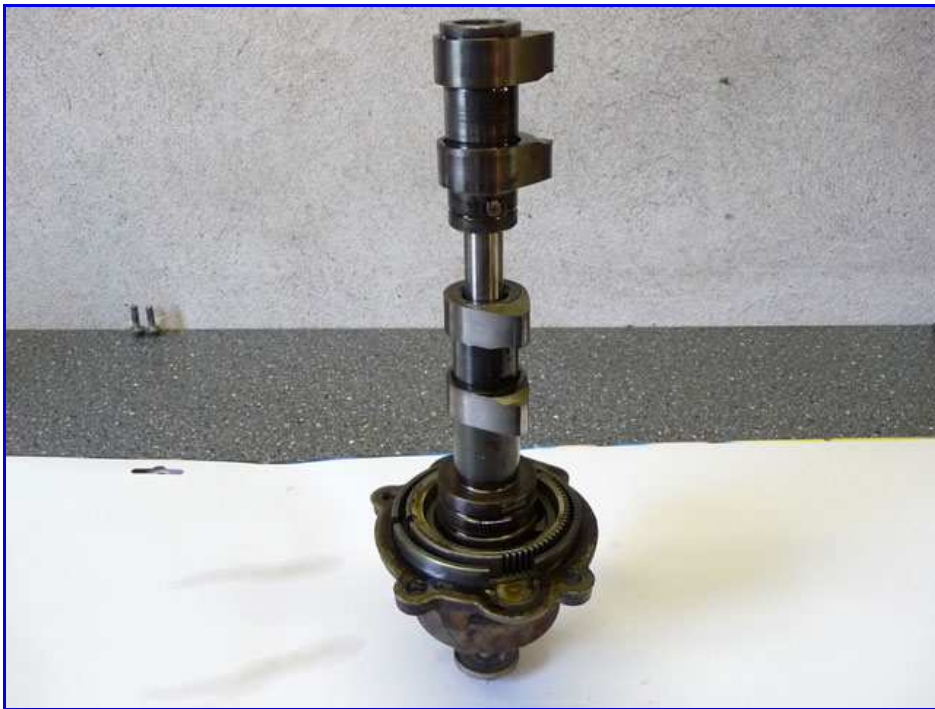
By removing the two remaining bolts and lifting the cross-shaft slightly, the whole cams/mech assembly comes out like this.

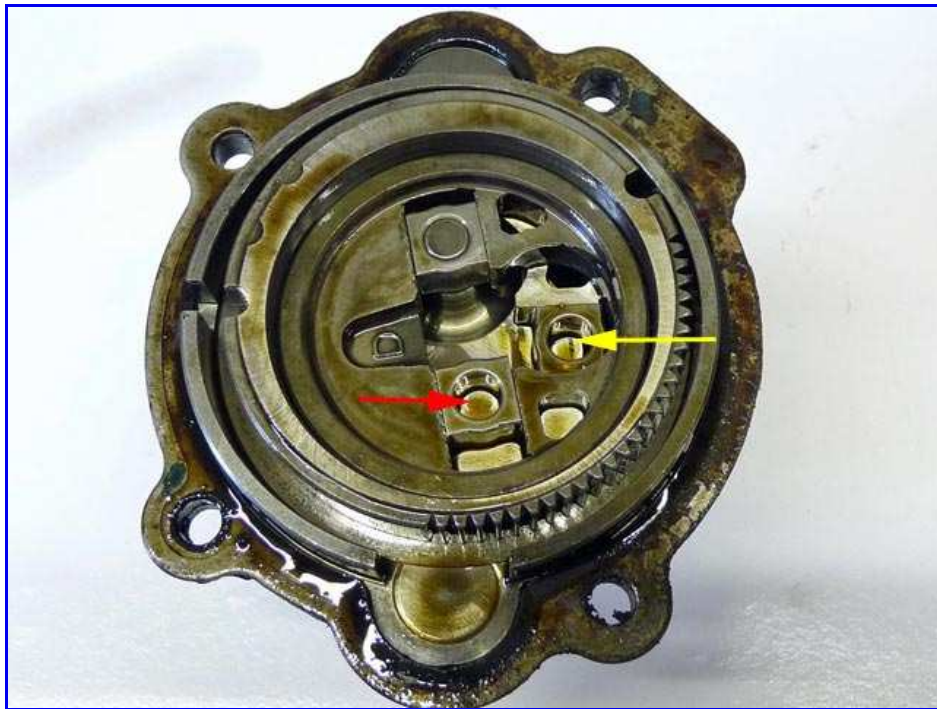
...which fit in these holes.

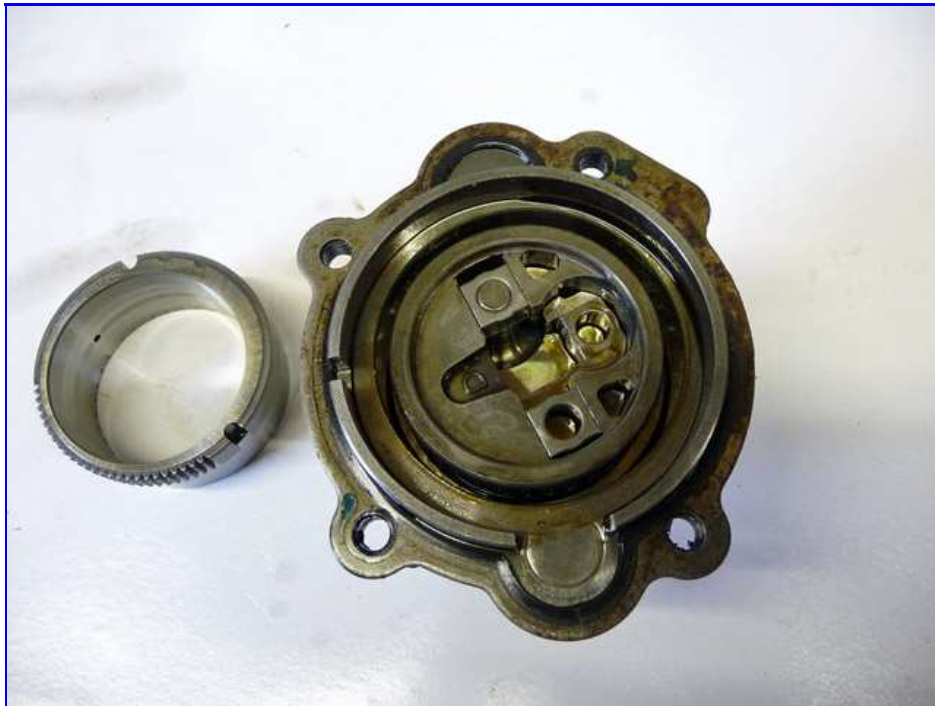
Next out is this eccentric collar.

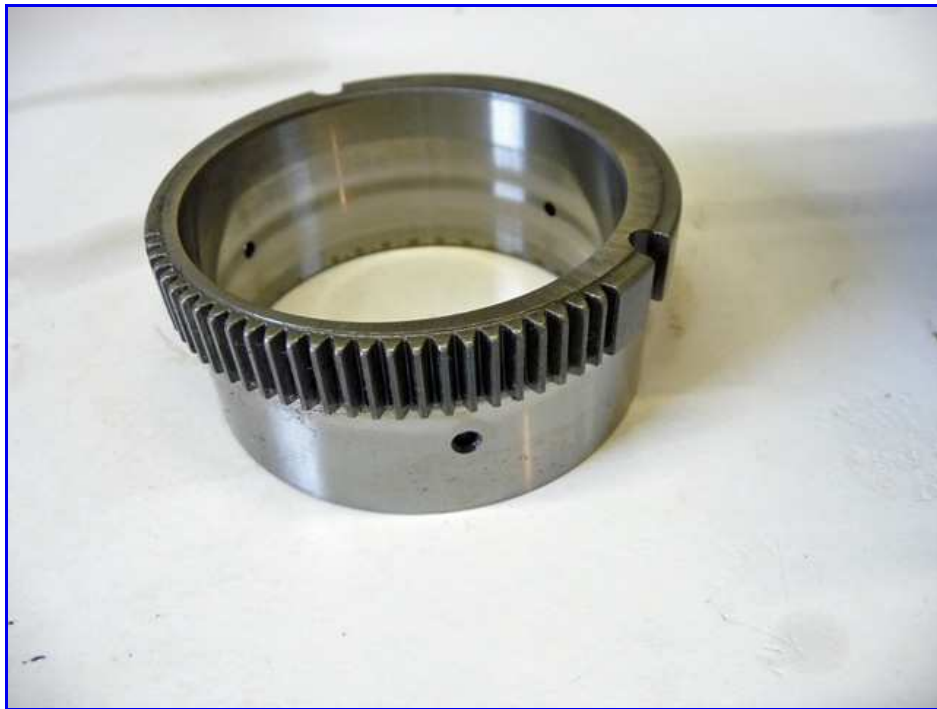
A few wear marks can be seen, but not felt.

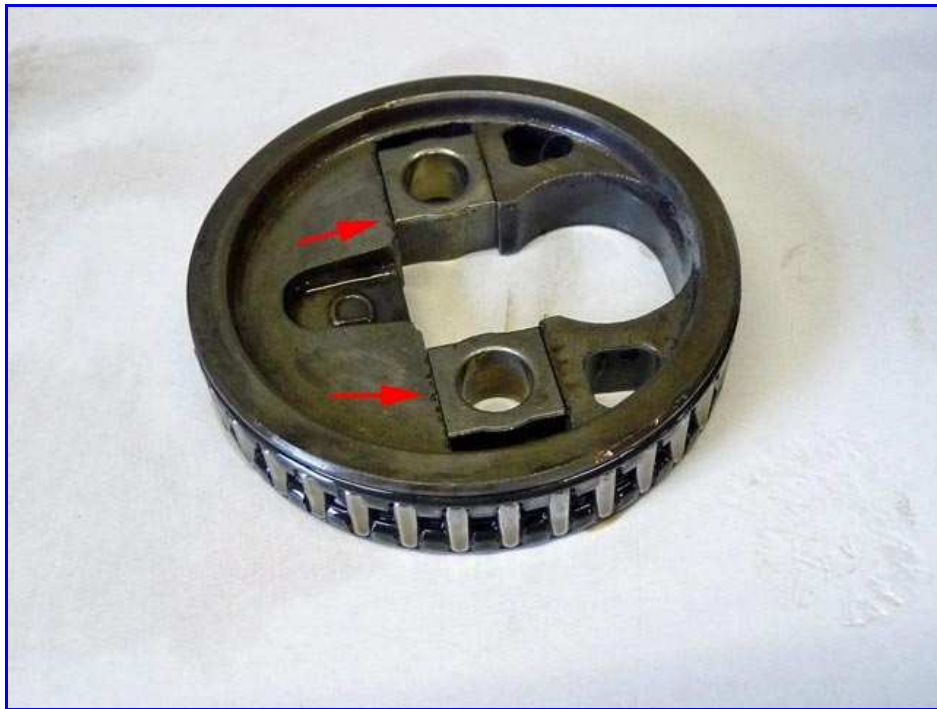
The top layer in close up. Are these nicks cause for concern?

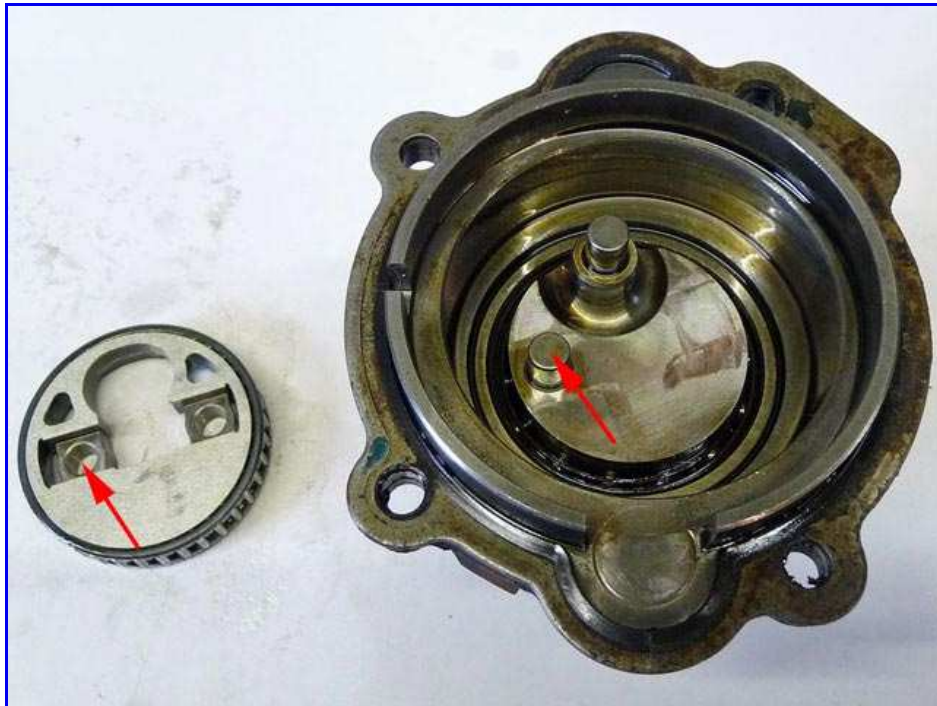
The next layer out, again showing what went where.

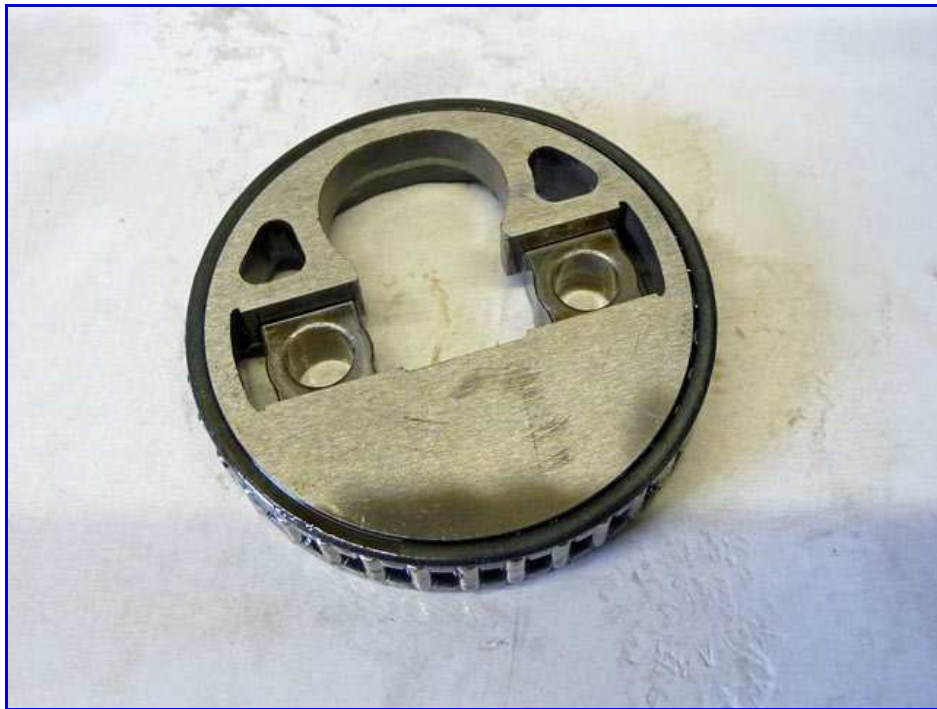
A closer look at the second layer of components.

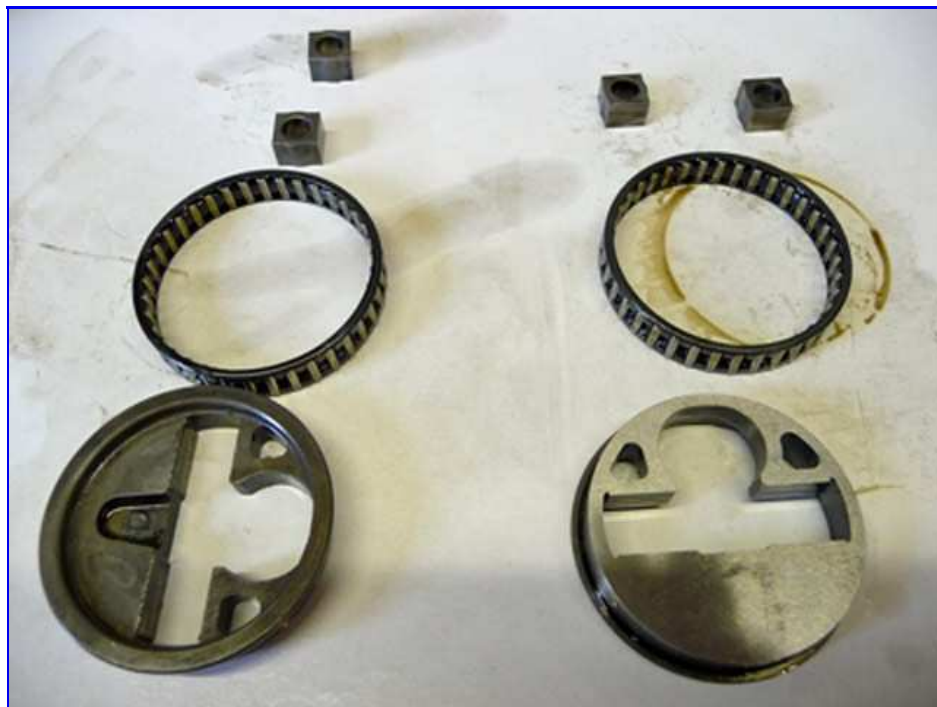
All the internal components out - that wasn't too difficult! I'll be giving it all a good soak and clean in paraffin, then put it all back together exactly as it was. It'll be interesting to compare the condition of these bits (and those from Ken's other VVC mechanism) with the ones from my engine.

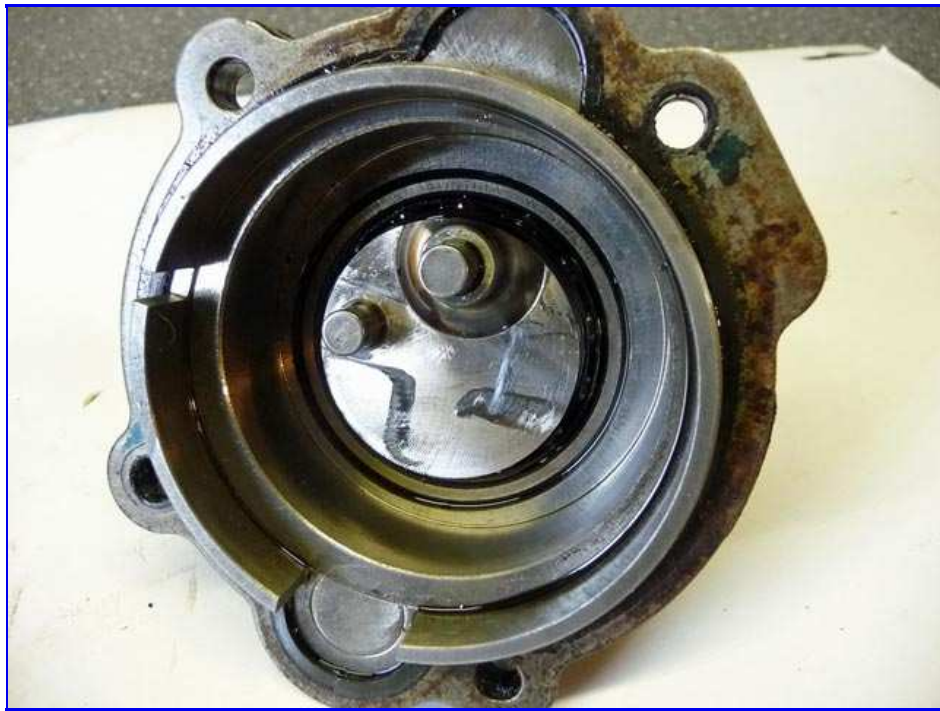
Just the drive flange, bearing and seal left in. I won't be attempting to take these out, as the bearing rotates smoothly, with no play. There are some visible wear marks on the face of the flange, but again they cannot be felt with a finger nail.

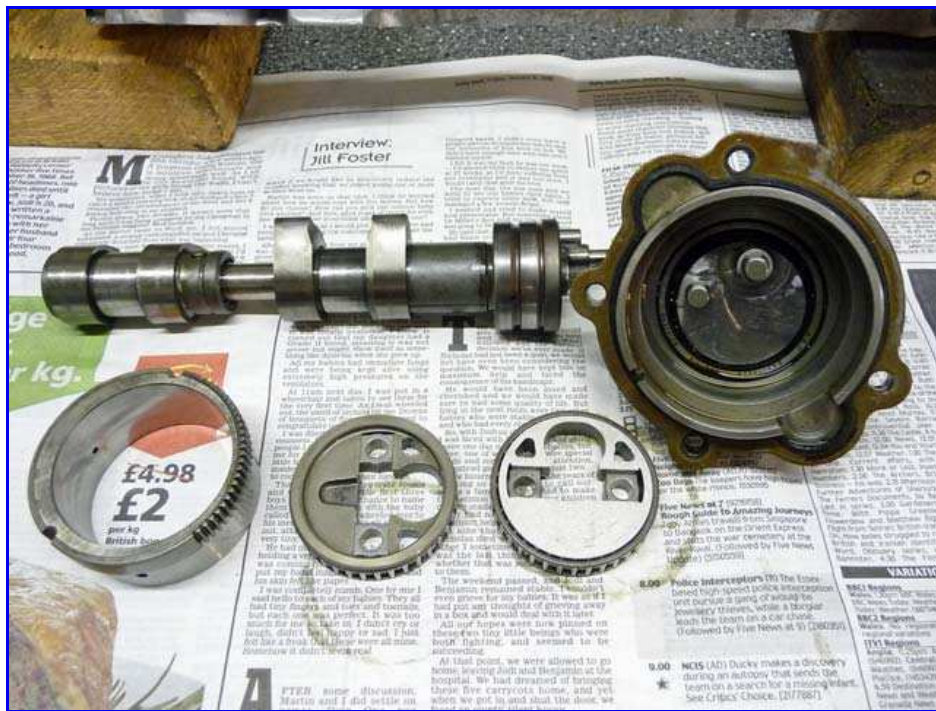
The internal components of one of my VVC mechanisms. They appear to be in even better condition than those from Ken's engine - everything is cleaner and brighter, they have fewer visible scuff marks and none of the nicks mentioned above. I'm no expert on these matters, but I can't really see or feel anything that could cause the rattling I was getting. I'm going to clean, oil and reassemble my mechs and then put them back in my engine. That'll avoid any possible compatibility issues.

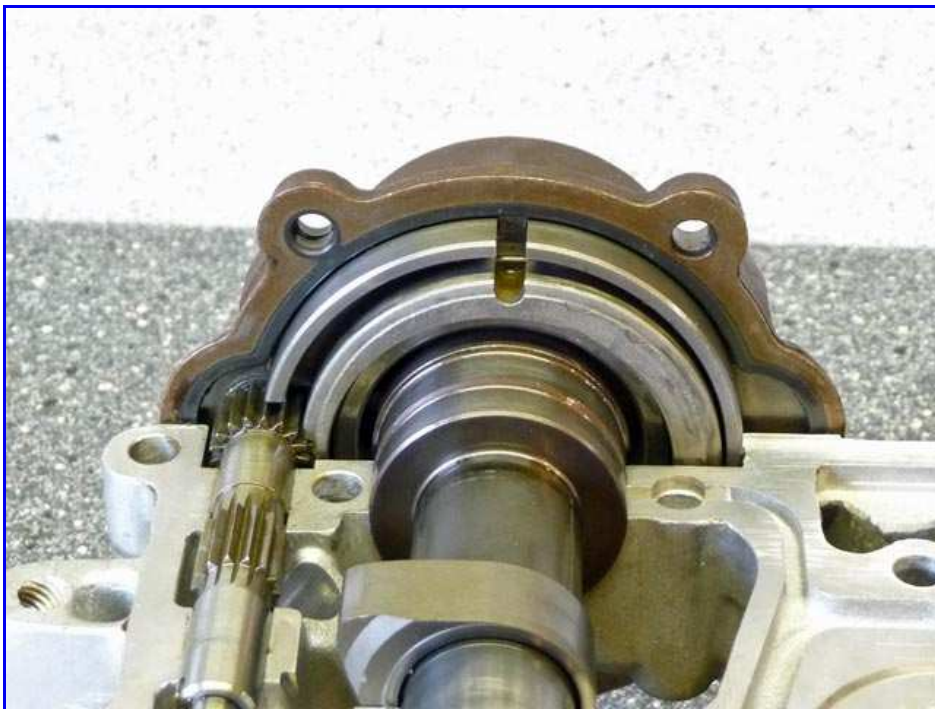
The mech is then rotated back so that the cross shaft sits properly in the carrier and engages in the last teeth of the rotor. The mech is then loosely bolted to the cam carrier.

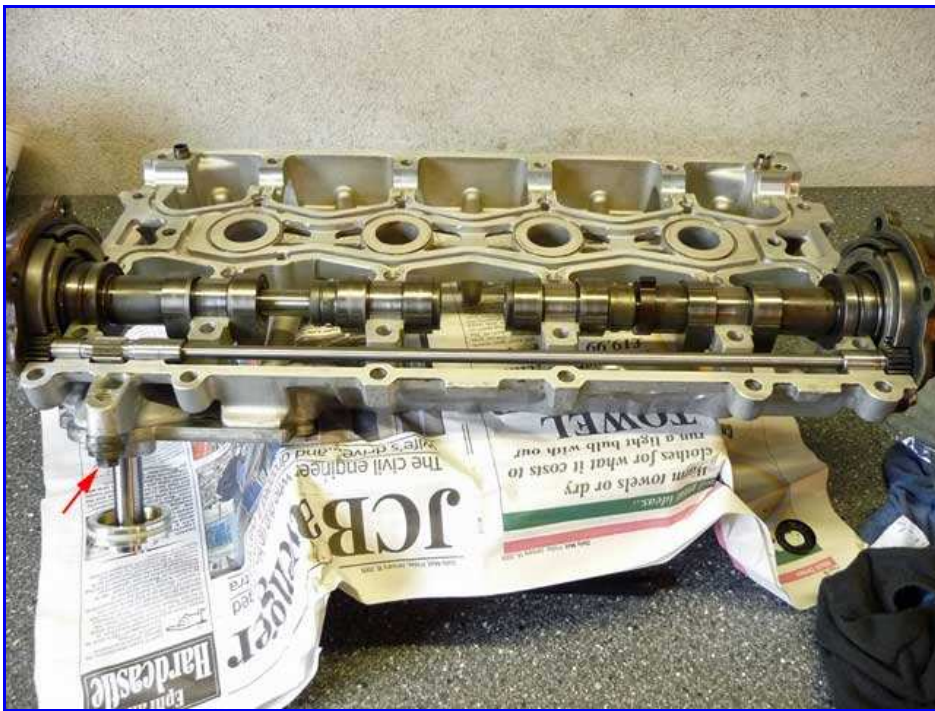
With a slave bolt holding the seal plate in position, the cam ladder is ready to have the sealant applied and can then be fitted to the cylinder head. Both sets of cams have been rotated so that the lobes point away from the followers, which should aid fitting. The exhaust cam will be fitted in the head and the carrier placed over it.
