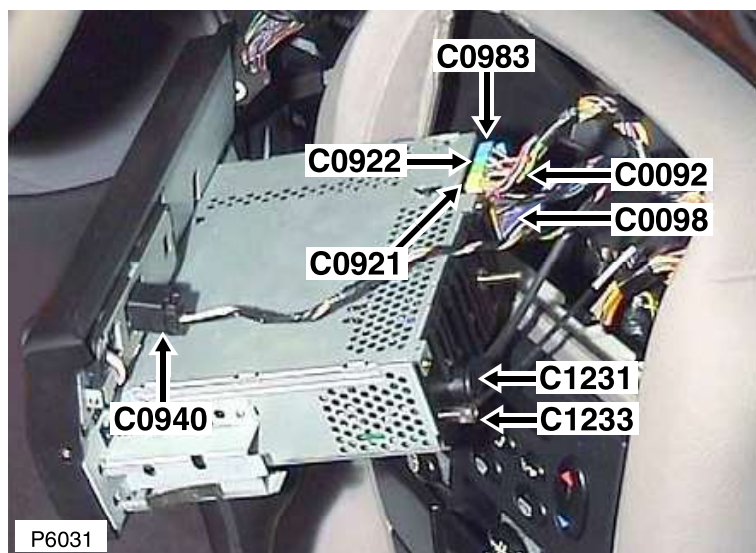
Description: *Radio / cassette player*

Location: *Behind radio*

Colour: *GREEN*

Gender: *Female*

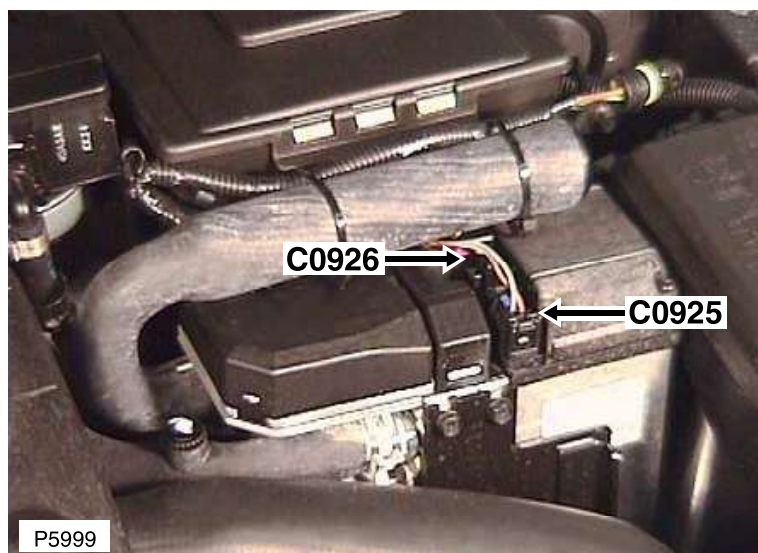
Description: *Heater - Fuel burning - M47R*

Location: *Front LH side of engine compartment*

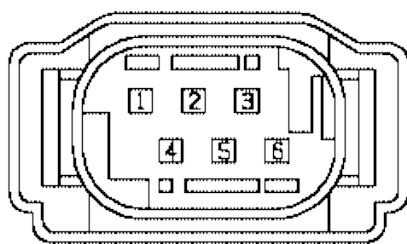
YPC110680

Colour: *BLACK*

Gender: *Female*

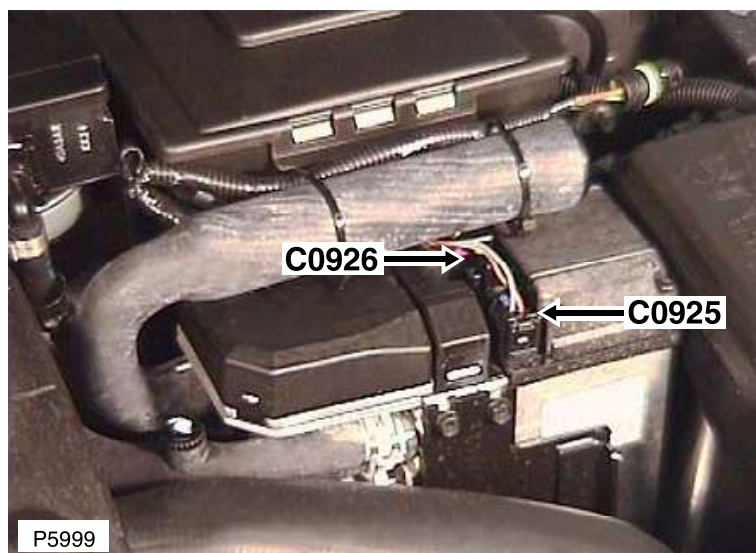
YPC115080

Description: *Heater - Fuel burning - M47R*

Location: *Front LH side of engine compartment*

Colour: *BLACK*

Gender: *Female*

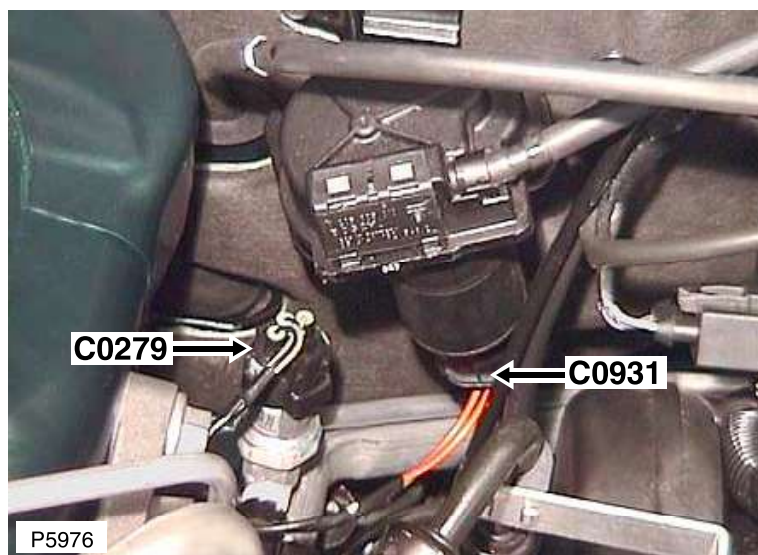
YPC110300

Description: *Motor - Traction control*

Location: *Rear RH side of engine compartment*

Colour: *BLACK*

Gender: *Female*

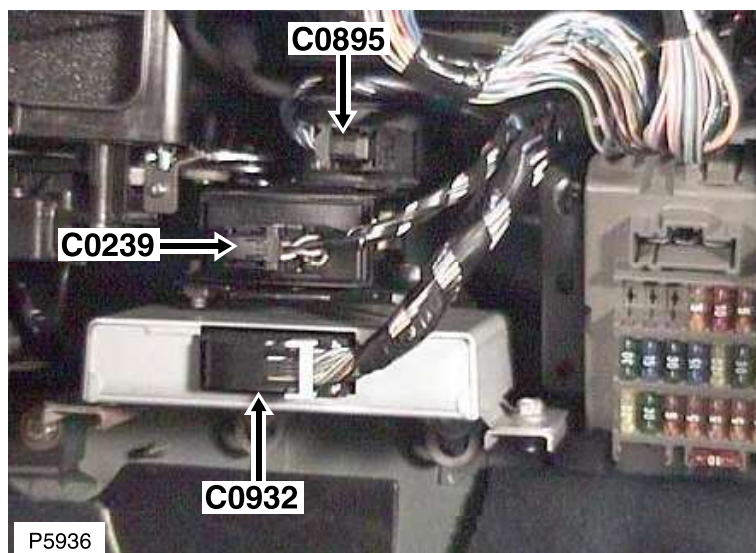
Description: *ECU - Electronic automatic transmission*

Location: *Behind passenger side of fascia*

Colour: *BLACK*

Gender: *Female*

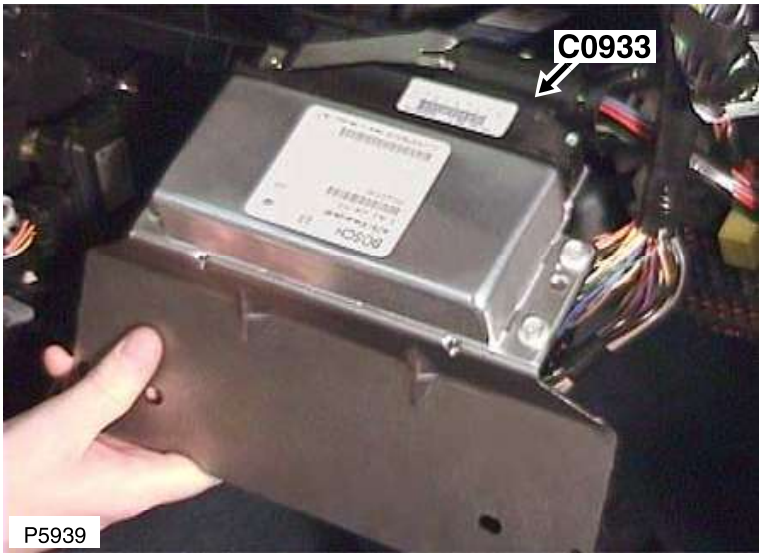
Description: *ECU - Traction control*  
Location: *Behind passenger side of fascia*

Colour: *BLACK*  
Gender: *Female*

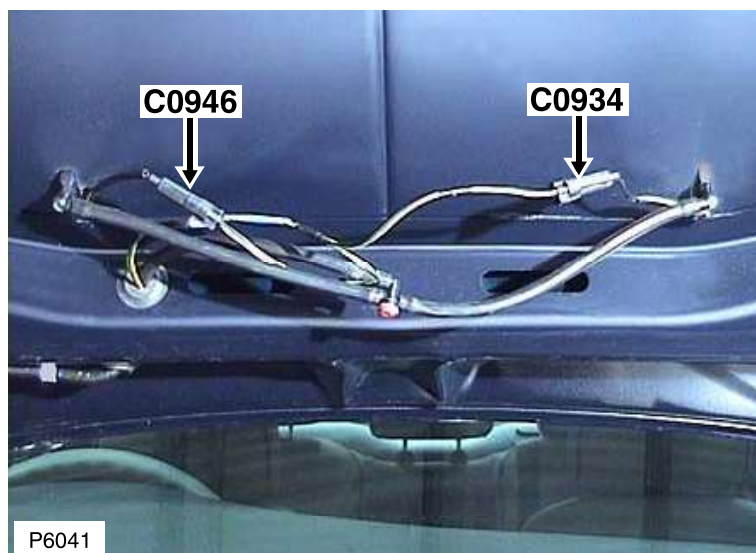
YPC110600

Description: *Washer jet - Heated*

Location: *Underside of bonnet*

Colour: *LIGHT BLUE*

Gender: *Female*

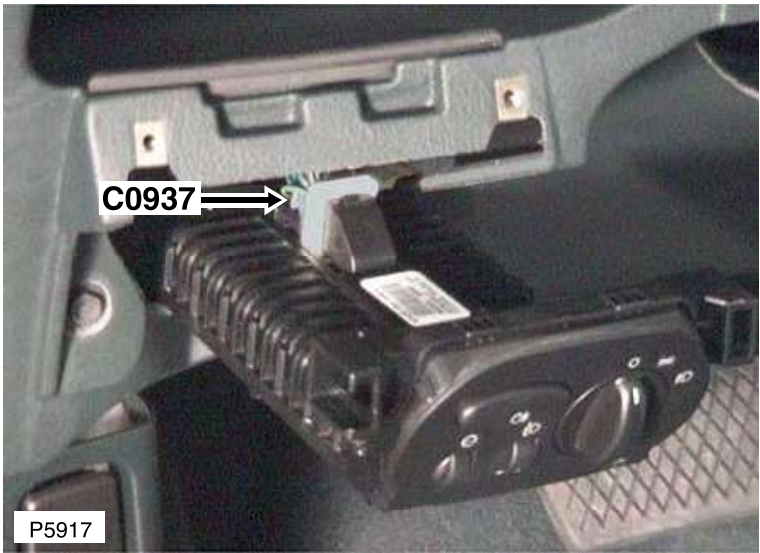
Description: *Module - Lighting switch*  
Location: *Behind driver side of fascia*

Colour: *BLACK*  
Gender: *Female*

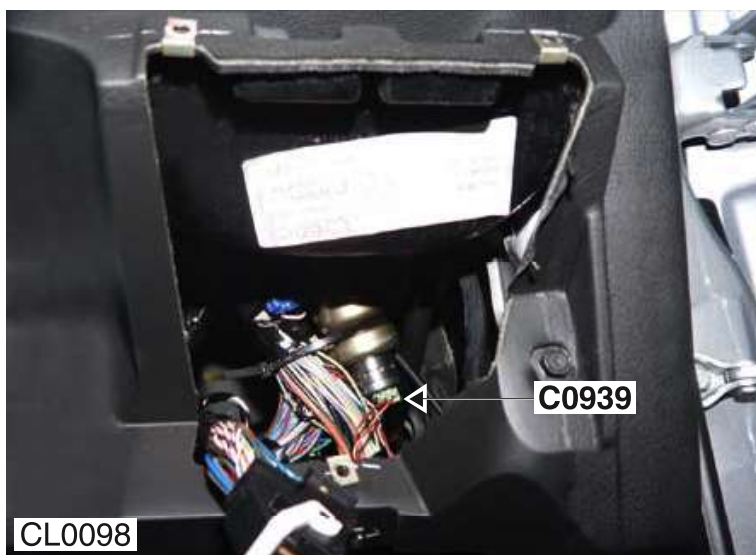
Y130001910

Description: *Airbag - head*

Location: *Behind RH side of fascia*

Colour: *GREEN*

Gender: *Female*

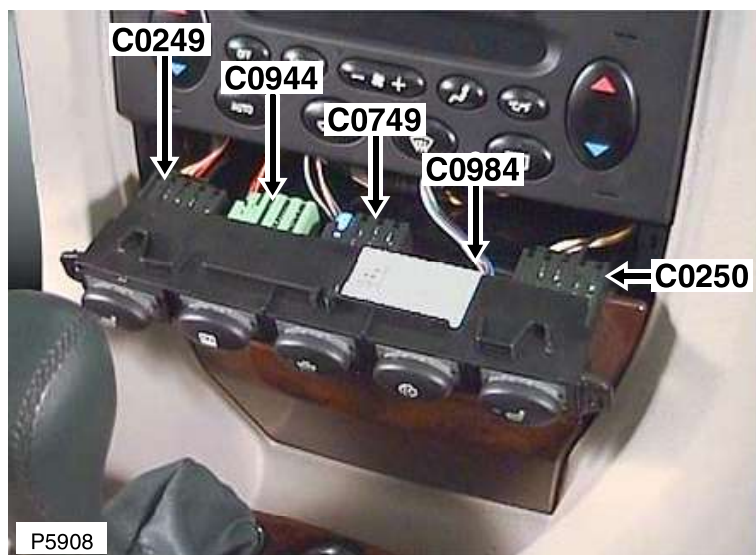
Description: *Switch - Sun blind*  
Location: *Behind centre console*

Colour: *BLACK*  
Gender: *Female*

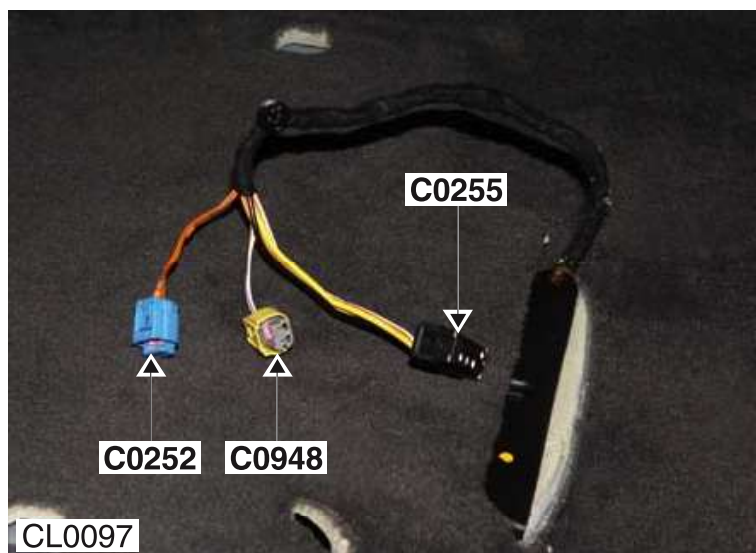
Description: *Airbag - Side - LH - RHD*

Location: *Beneath front passenger's seat*

Colour: *YELLOW*

Gender: *Female*

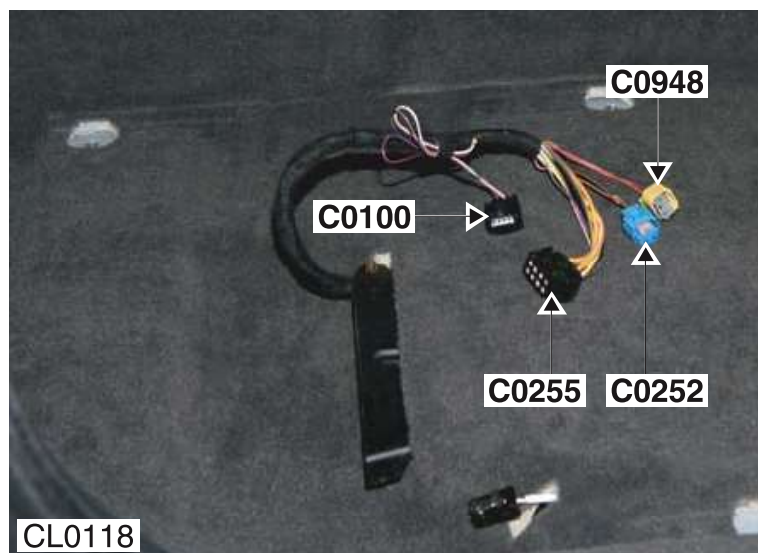
Description: *Airbag - Side - LH - LHD*  
Location: *Beneath driver's seat*

Colour: *YELLOW*  
Gender: *Female*

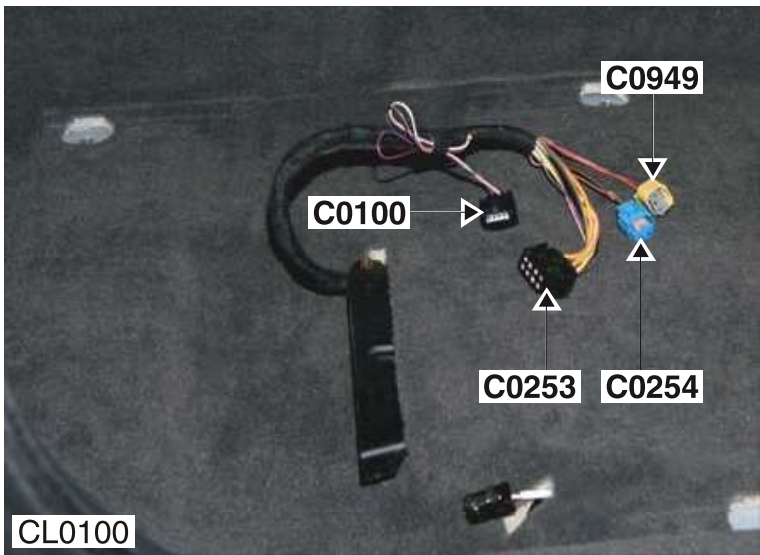
Description: *Airbag - Side - RH - RHD*  
Location: *Beneath driver's seat*

Colour: *YELLOW*  
Gender: *Female*

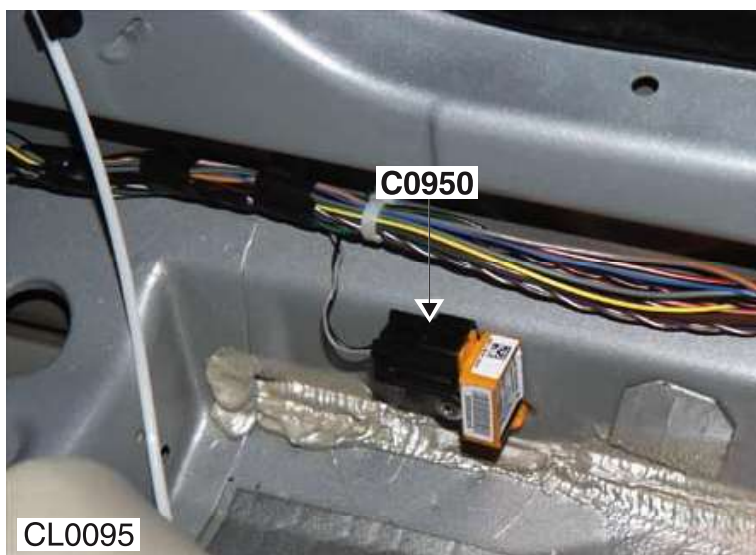
YPC001630

Description: *Sensor - Airbag - Side - LH*

Location: *Base of 'B' post LH side*

Colour: *BLACK*

Gender: *Female*

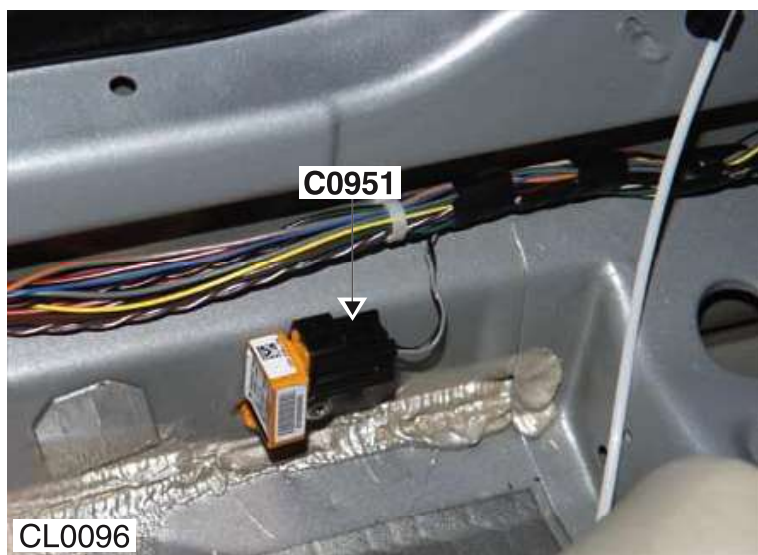
YPC001630

Description: *Sensor - Airbag - Side - RH*  
Location: *Base of 'B' post RH side*

Colour: *BLACK*  
Gender: *Female*

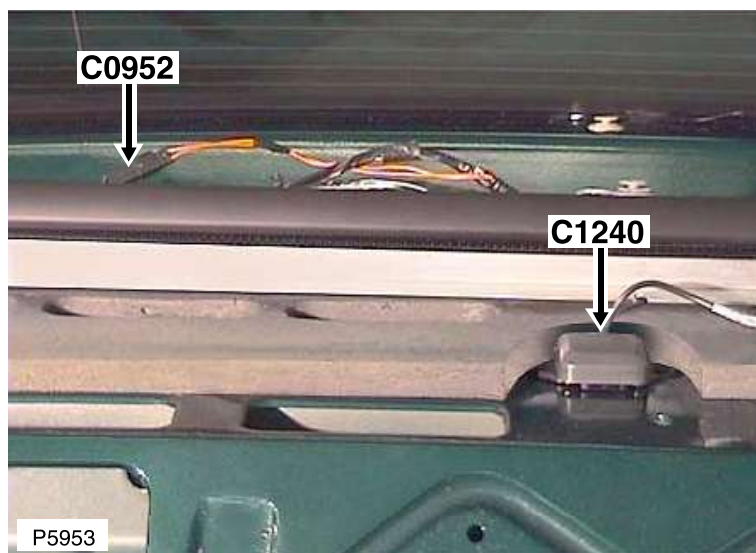
YPC117800

Description: *Motor - Sun blind*

Location: *Parcel shelf - under right hand side*

Colour: *BLACK*

Gender: *Female*

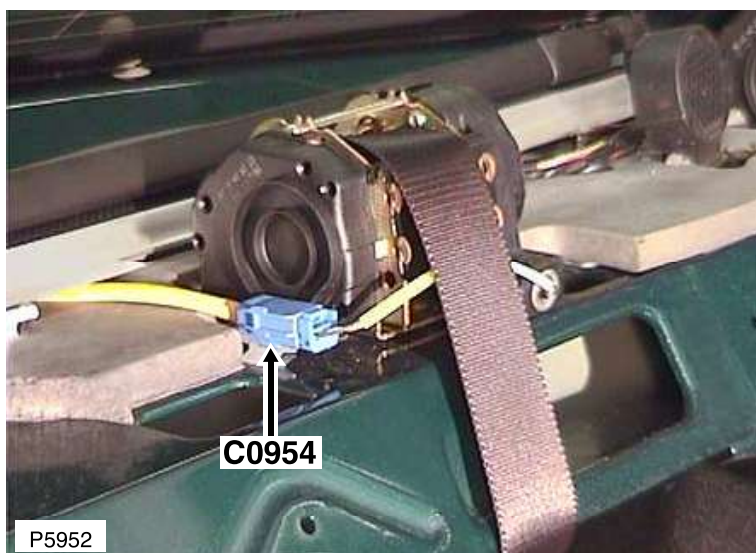
YIRC108820

Description: *Pre-tensioner - Rear - Centre*

Location: *Parcel shelf - under centre*

Colour: *BLUE*

Gender: *Male*

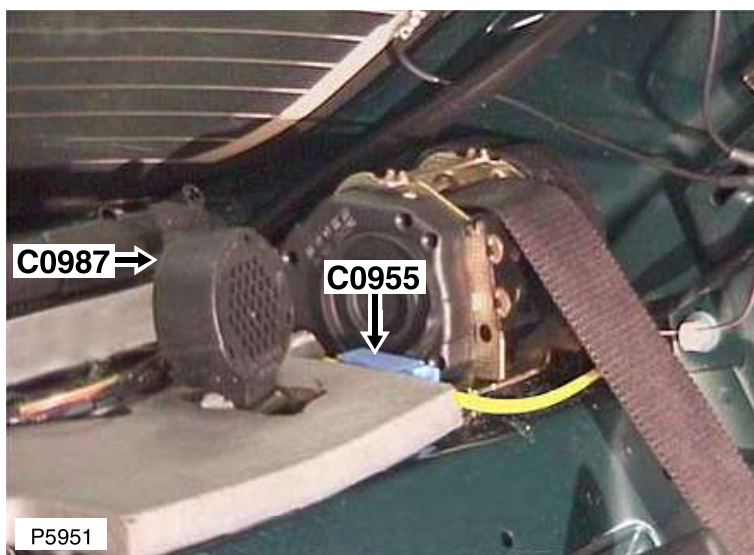
YPC108820

Description: *Pre-tensioner - Rear - LH - RHD*

Location: *Parcel shelf - under left hand side*

Colour: *BLUE*

Gender: *Male*

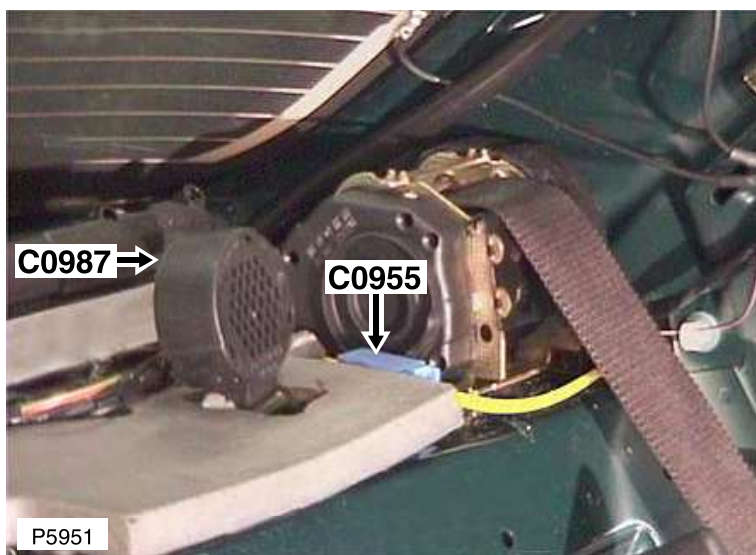
YIRC108820

Description: *Pre-tensioner - Rear - LH - LHD*  
Location: *Parcel shelf - under left hand side*

Colour: *BLUE*  
Gender: *Male*

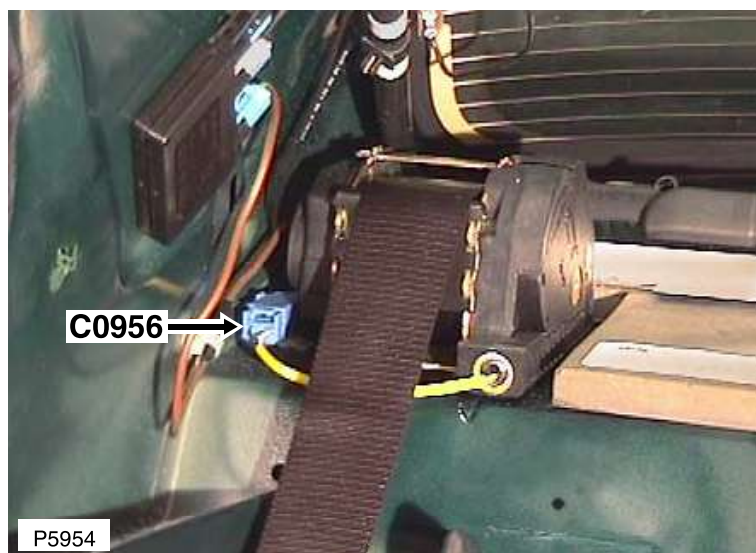
YPC108820

Description: *Pre-tensioner - Rear - RH - RHD*

Location: *Parcel shelf - under right hand side*

Colour: *BLUE*

Gender: *Male*

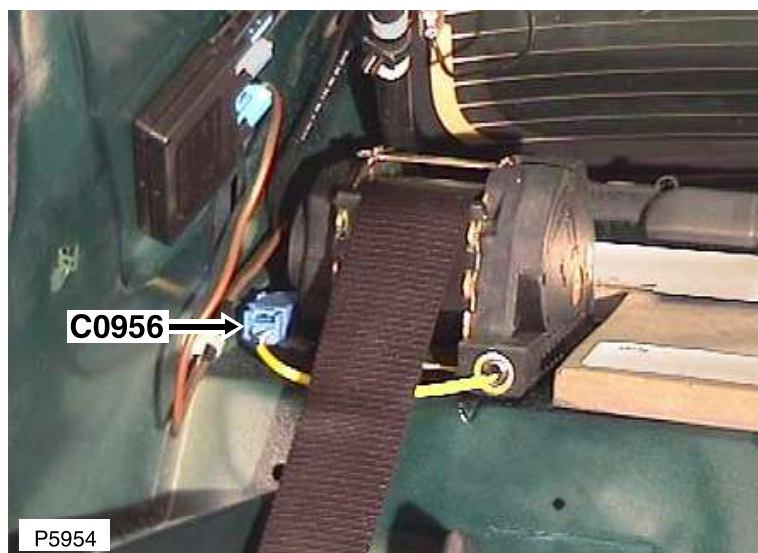
YIRC108820

Description: *Pre-tensioner - Rear - RH - LHD*

Location: *Parcel shelf - under right hand side*

Colour: *BLUE*

Gender: *Male*

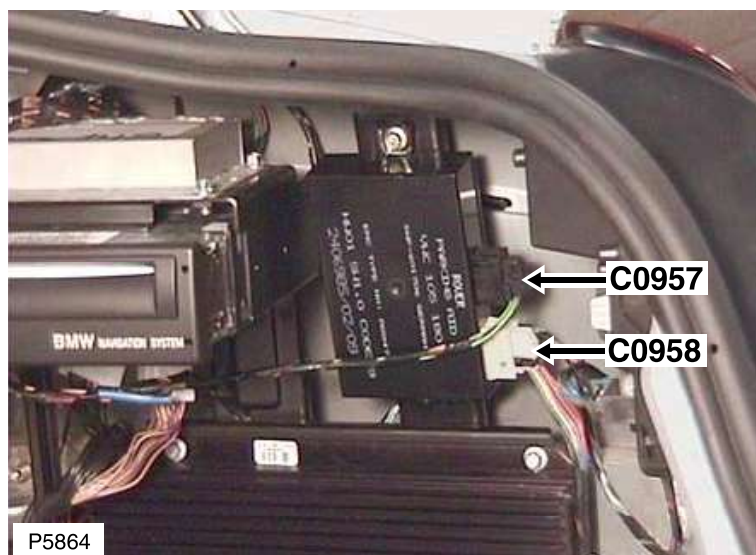
Description: *ECU - Park - Distance control*

Location: *Behind luggage compartment carpet RH side*

Colour: *BLACK*

Gender: *Female*

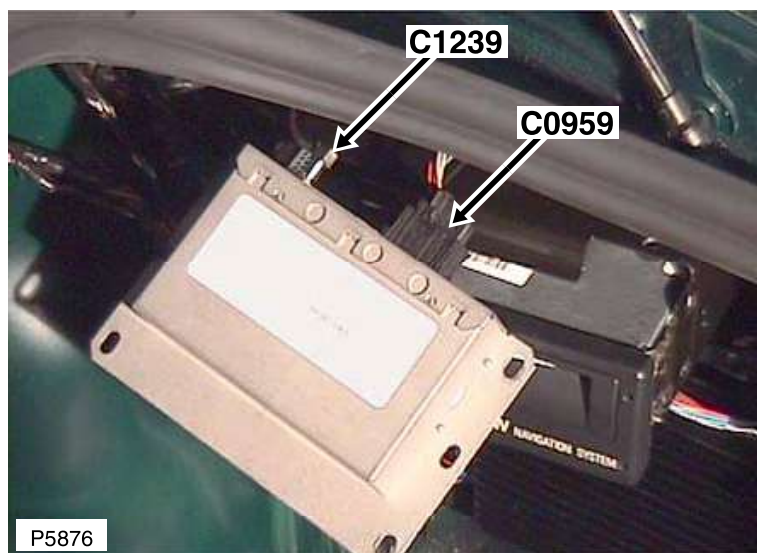
Description: *Reciever - Navigation*

Location: *Behind luggage compartment carpet RH side*

Colour: *BLACK*

Gender: *Female*

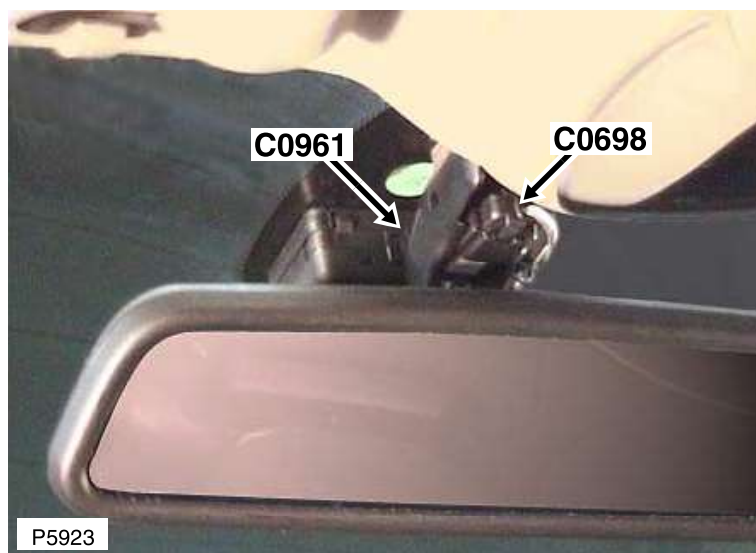
YPC117840

Description: *Sensor - Rain*

Location: *Rear view mirror*

Colour: *BLACK*

Gender: *Female*

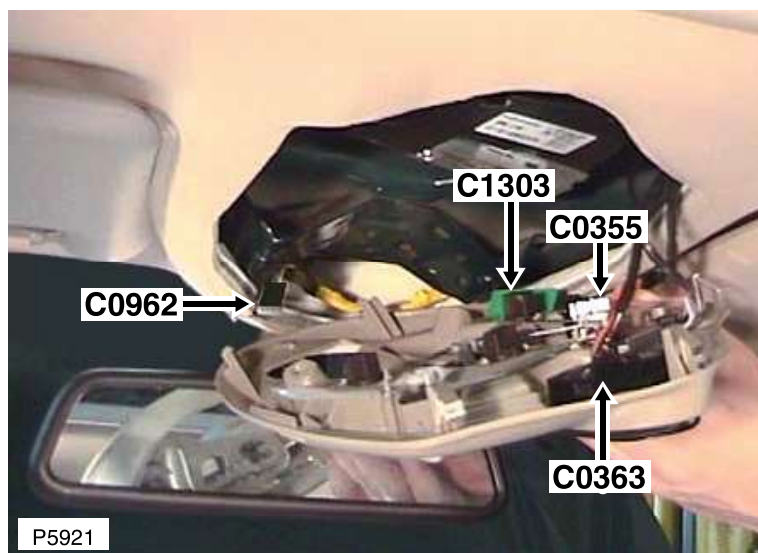
YPC117850

Description: *Sensor - Occupancy detection*

Location: *Behind interior light*

Colour: *WHITE*

Gender: *Female*

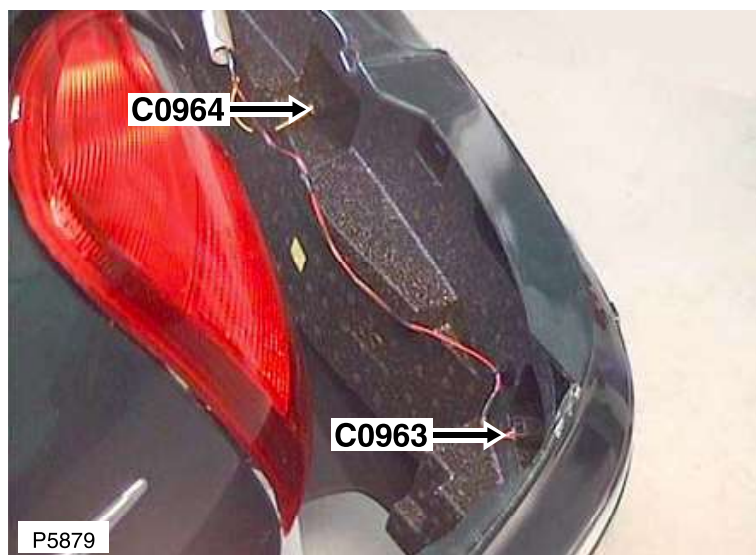
YPC116860

Description: *Sensor - PDC - Outer - Rear - LH*

Location: *Behind LH side of rear bumper*

Colour: *GREY*

Gender: *Female*

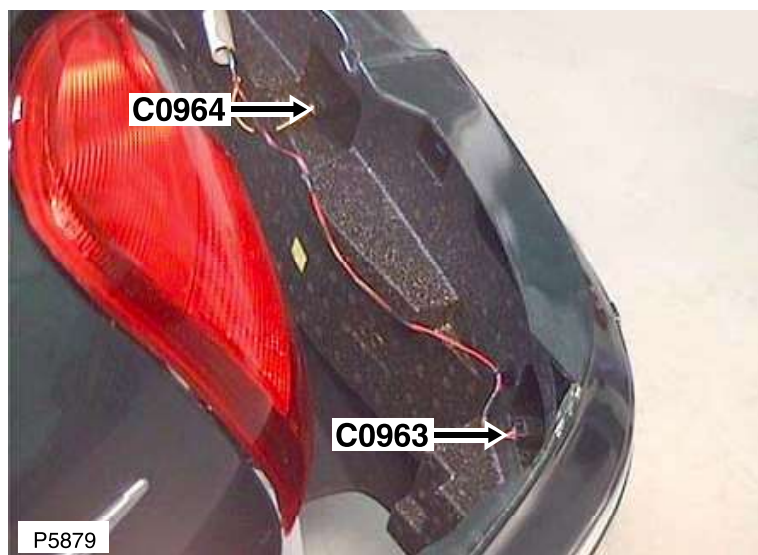
YPC116860

Description: *Sensor - PDC - Inner - Rear - LH*

Location: *Behind LH side of rear bumper*

Colour: *GREY*  
Gender: *Female*

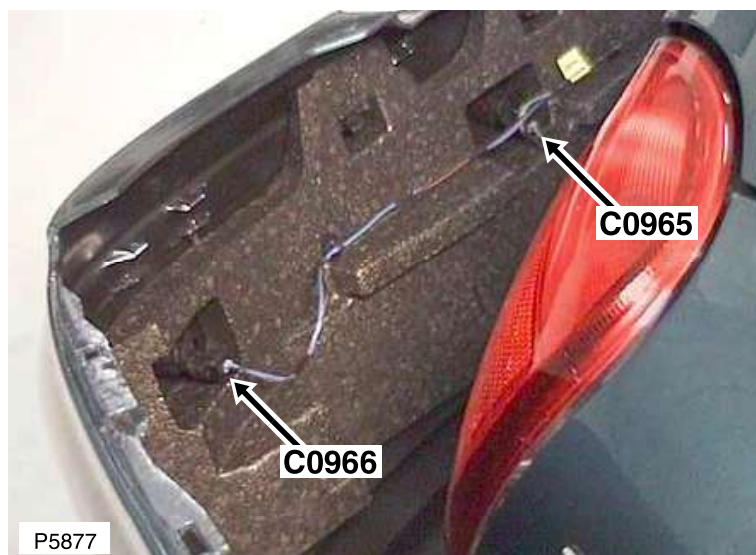
YPC116860

Description: *Sensor - PDC - Inner - Rear - RH*

Location: *Behind RH side of rear bumper*

Colour: *GREY*

Gender: *Female*

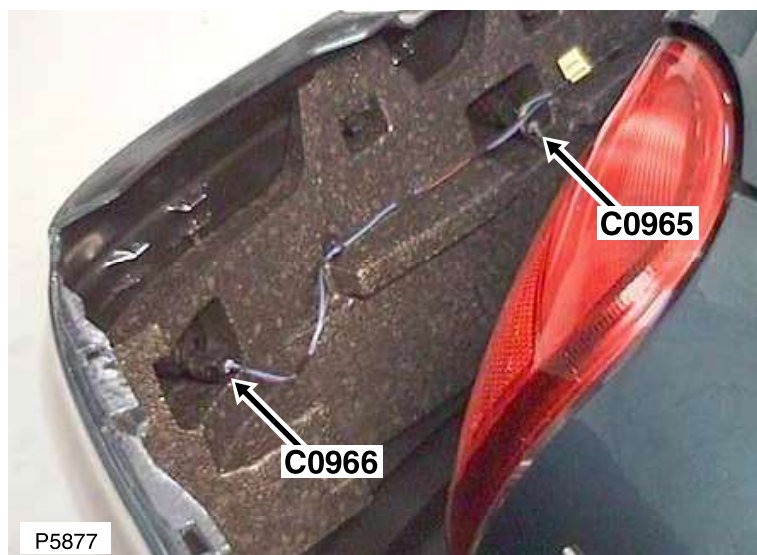
YPC116860

Description: *Sensor - PDC - Outer - Rear - RH*

Location: *Behind RH side of rear bumper*

Colour: *GREY*  
Gender: *Female*

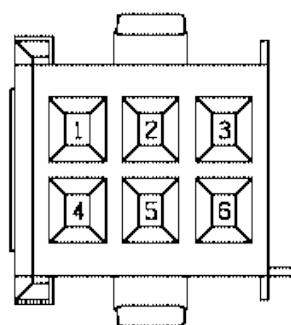
YPC115290

Description: *Switch - Boot release*

Location: *Base of driver side 'A' post*

Colour: *BLACK*

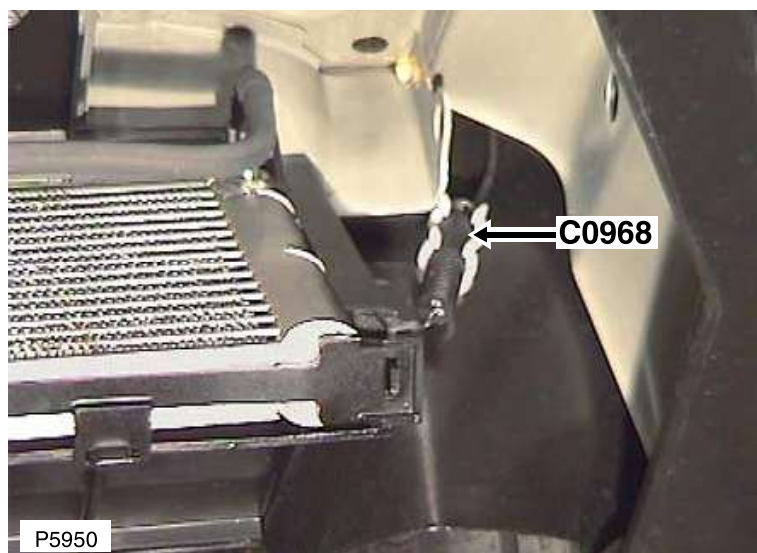
YPC 110480

Description: *Sensor - Pad wear*

Location: *Beneath rear of vehicle RH side*

Colour: *BLACK*

Gender: *Female*

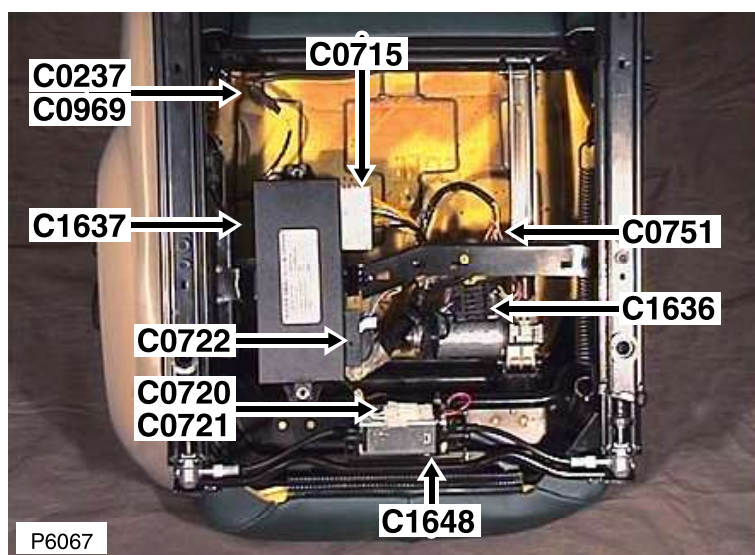
YPC111740

Description: *Heater - Seat cushion - RH*

Location: *Beneath driver's seat*

Colour: *BLACK*

Gender: *Female*

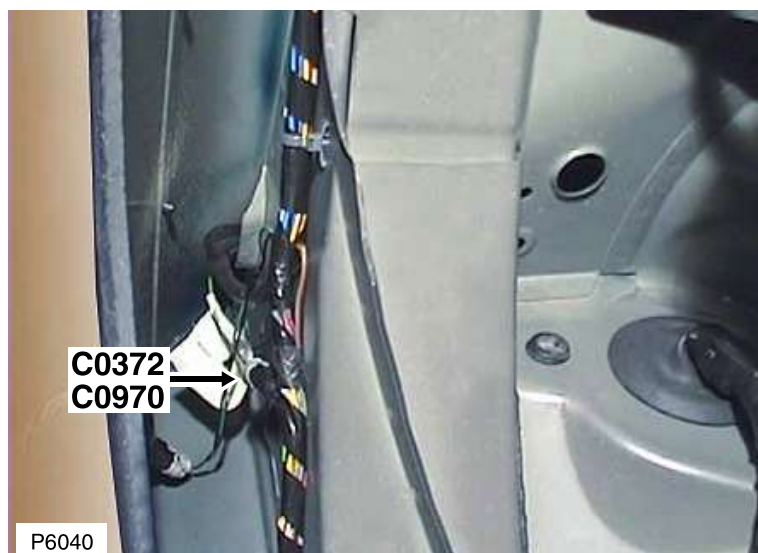
Description: *Main harness to heated washer jet harness*  
Location: *Behind RH front wheel arch liner*

Colour: *BLACK*  
Gender: *Male*

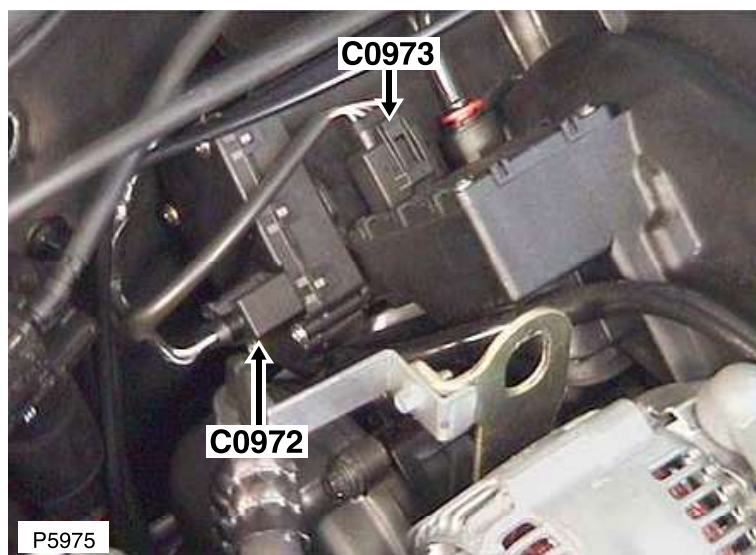
YPC113840

Description: *Valve - Variable intake solenoid - KV6*

Location: *Top of engine*

Colour: *BLACK*

Gender: *Female*

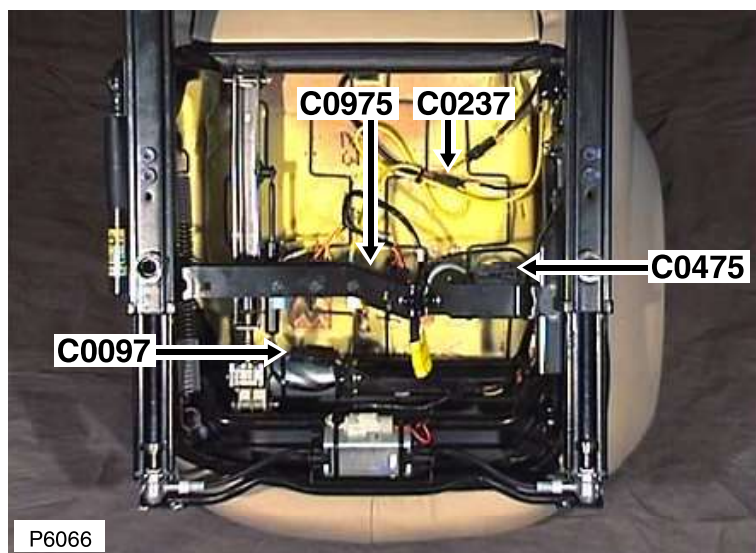
Description: *Relay - Seat*

Location: *Beneath driver's seat*

Colour: *BLACK*

Gender: *Female*

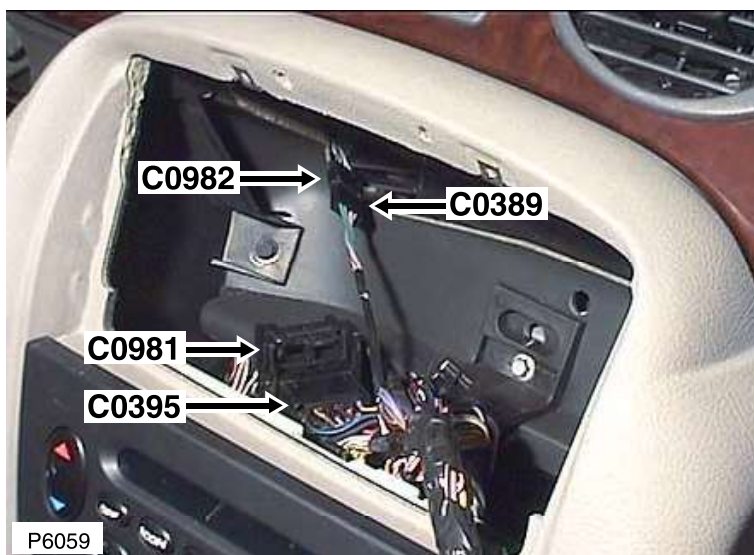
YPC111760

Description: *Main harness to radio harness*

Location: *Behind front of centre console*

Colour: *BLACK*

Gender: *Female*

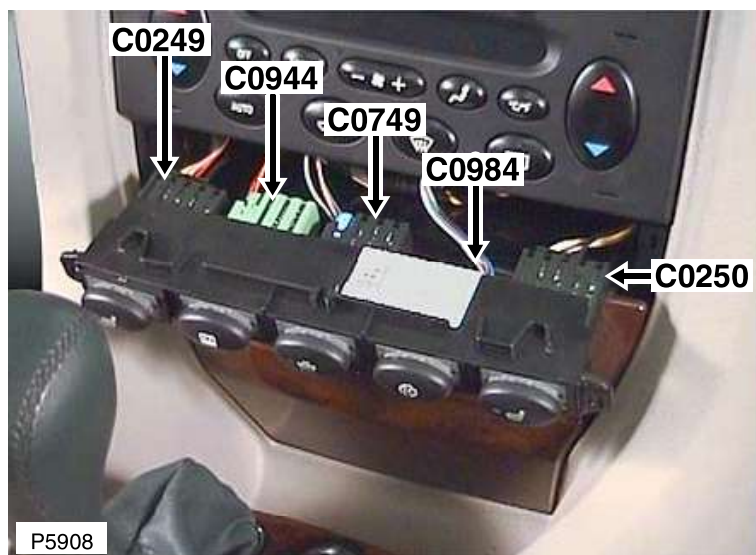
YPC115290

Description: *Switch - Traction control*

Location: *Behind centre console*

Colour: *BLACK*

Gender: *Female*

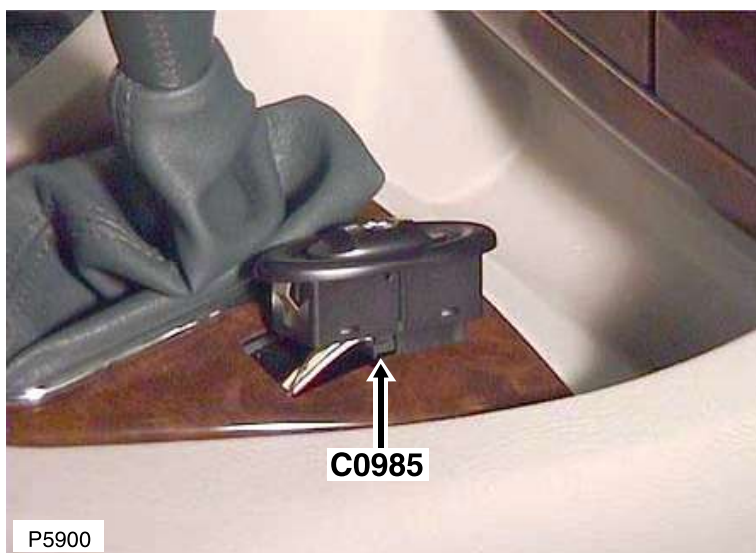
YPC111760

Description: *Switch - Sport/Snow*

Location: *Behind front of centre console*

Colour: *BLACK*

Gender: *Female*

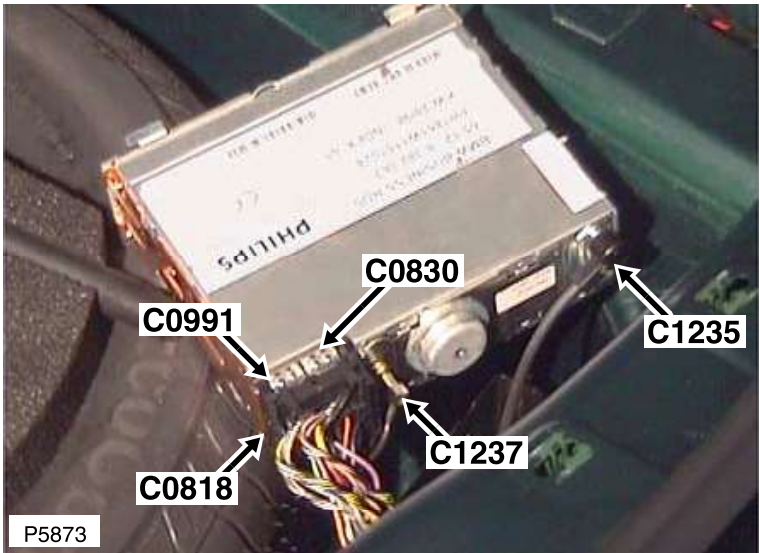
Description: *Radio - Rear*  
Location: *Rear of luggage compartment - RH side*

Colour: *BLACK*  
Gender: *Female*

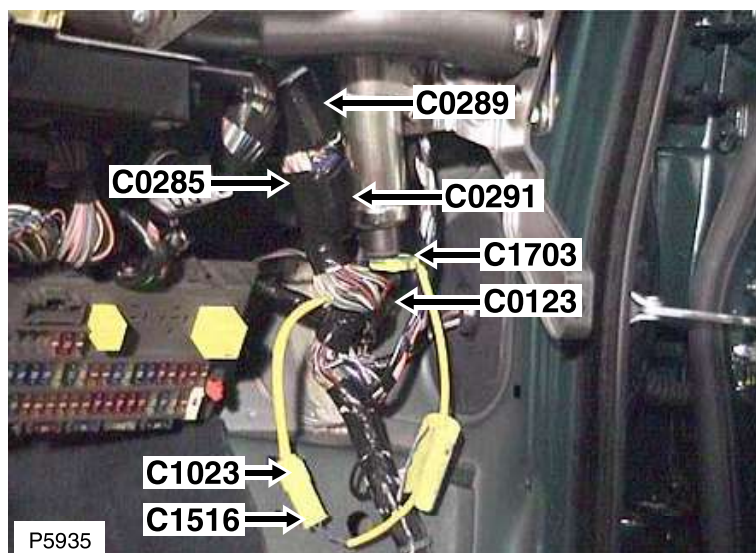
YPC116050

Description: *Main harness to SRS harness*

Location: *Behind RH side of fascia*

Colour: *YELLOW*

Gender: *Female*

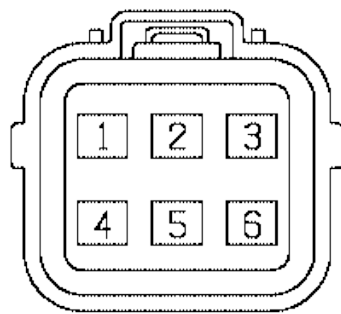
YPC 10542

Description: *Main harness to front fog lamp harness*

Location: *Front corner of engine compartment - LH side*

Colour: *GREY*  
Gender: *Female*

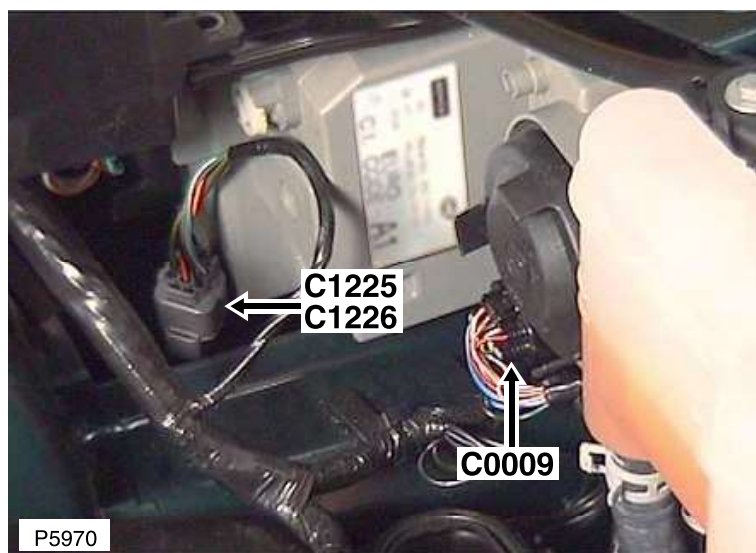
YPC106620

Description: *Front fog lamp harness to main harness*

Location: *Front corner of engine compartment - LH side*

Colour: *GREY*

Gender: *Male*

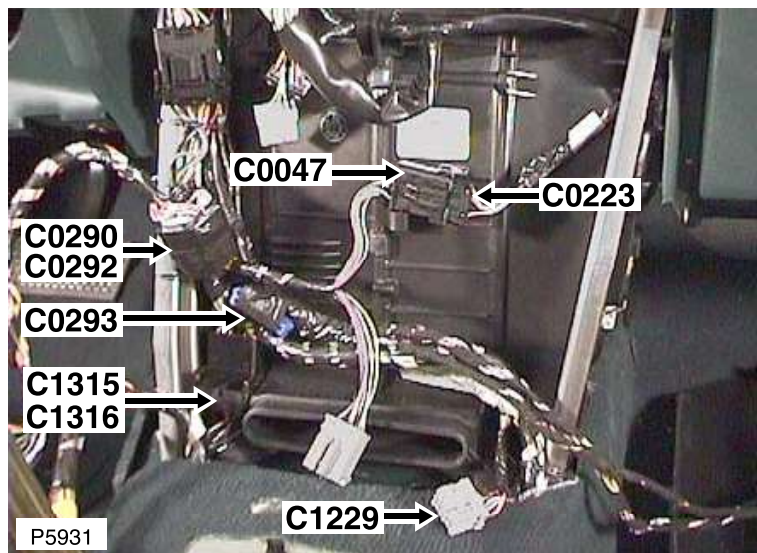
YPC 10492

Description: *I.C.E. harness to telephone harness*

Location: *Behind front of centre console*

Colour: *LIGHT GREY*

Gender: *Female*

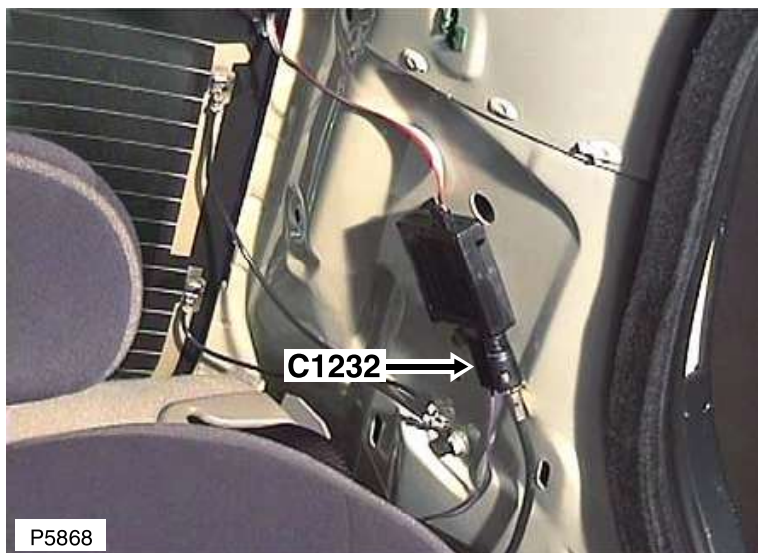
Description: *Co-axial cable*

Location: *LH 'D' post*

Colour: *TIN-PLATE*

Gender: *Female*

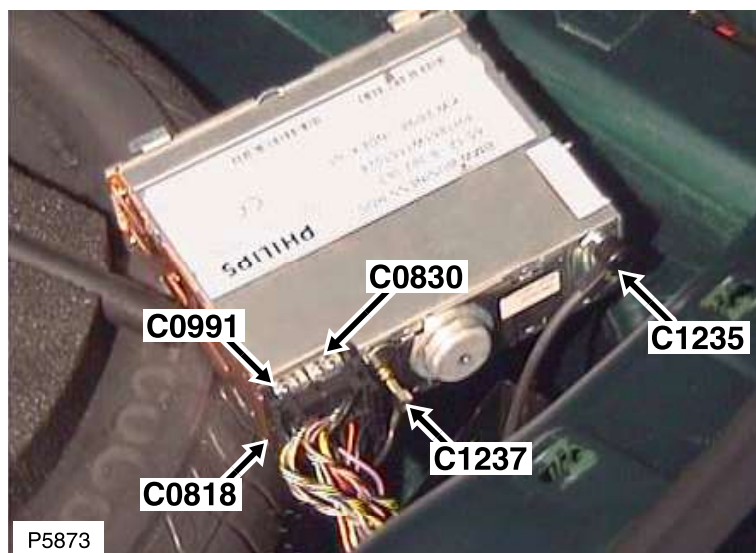
51277143

Description: *Cable - Co-axial - Rear radio*

Location: *Rear of luggage compartment - RH side*

Colour: *TIN-PLATE*

Gender: *Female*

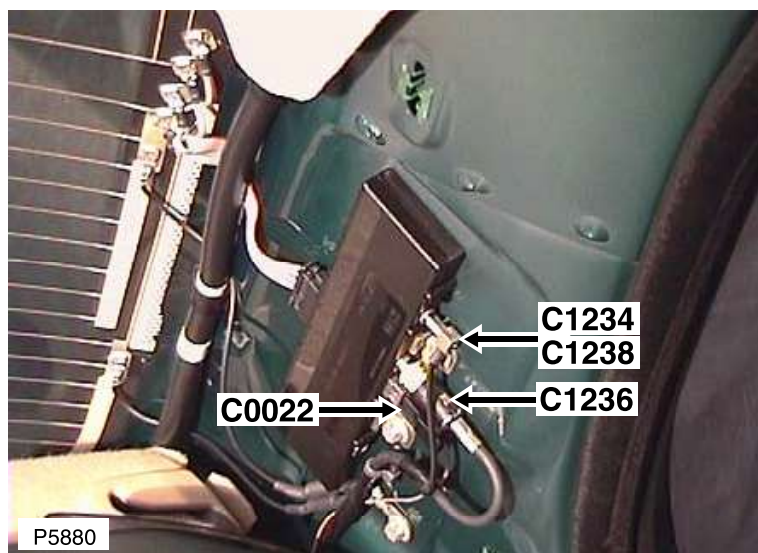
Description: *Co-axial cable*

Location: *LH 'D' post*

Colour: *TIN-PLATE*

Gender: *Female*

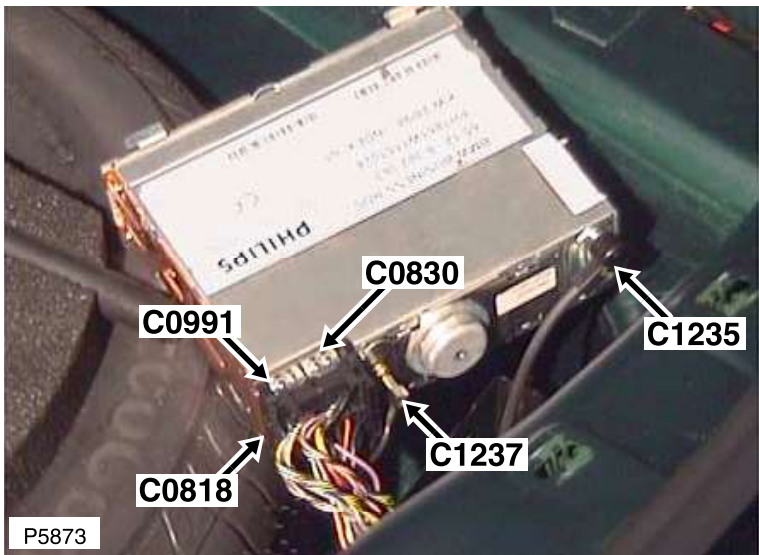
51277143

Description: *Cable - Co-axial - Rear radio - Diversity*  
Location: *Rear of luggage compartment - RH side*

Colour: *TIN-PLATE*  
Gender: *Female*

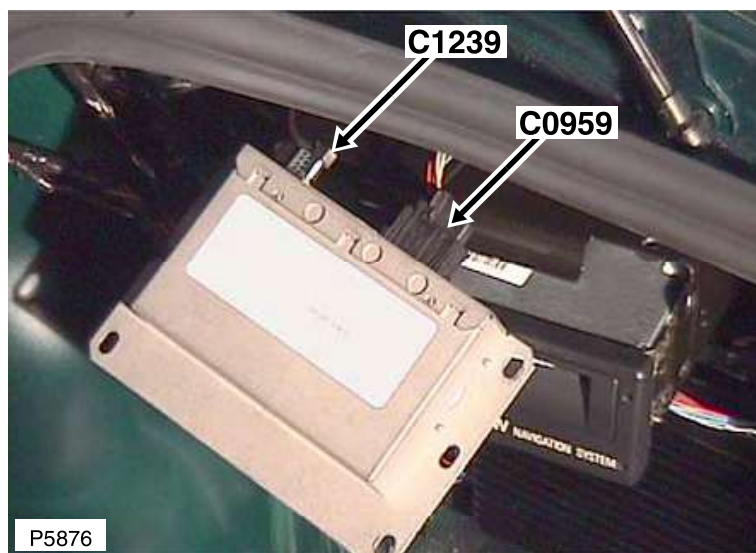
51277146

Description: *Cable - Co-axial - Navigation*

Location: *Behind luggage compartment carpet RH side*

Colour: *TIN-PLATE*

Gender: *Female*

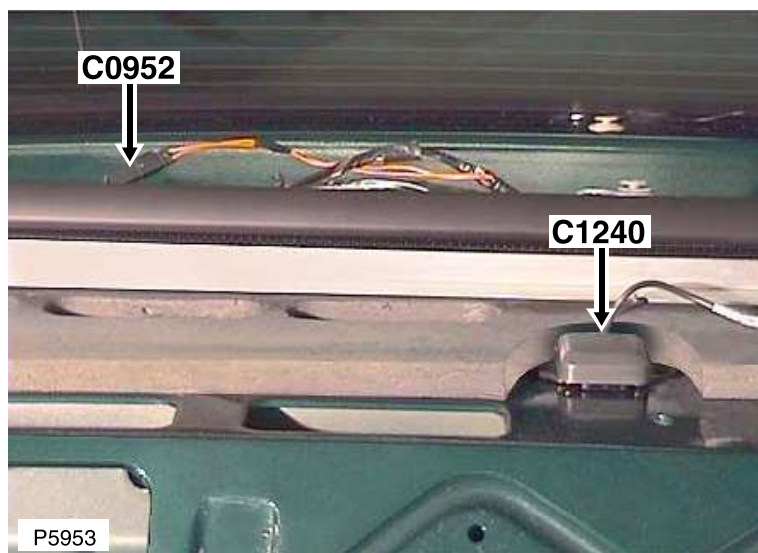
51277144

Description: *Cable - Co-axial - Navigation*

Location: *Parcel shelf - under centre*

Colour: *TIN-PLATE*

Gender: *Female*

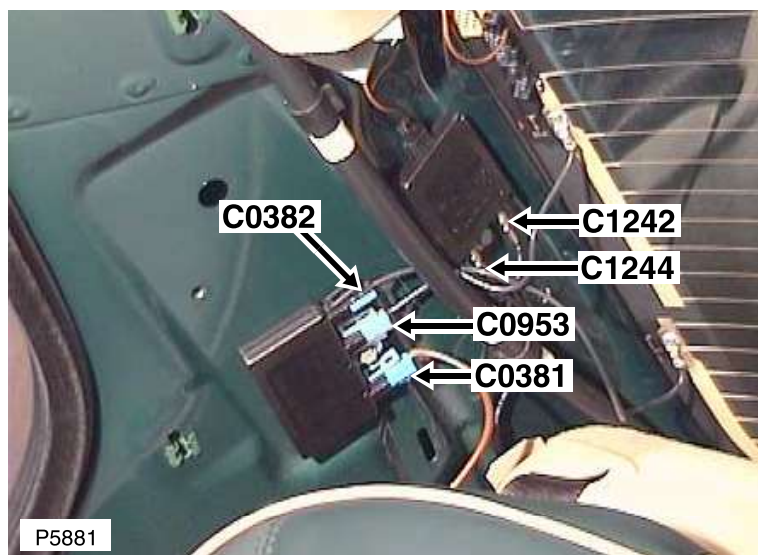
Description: *Cable - Co-axial - Video*

Location: *RH 'D' post*

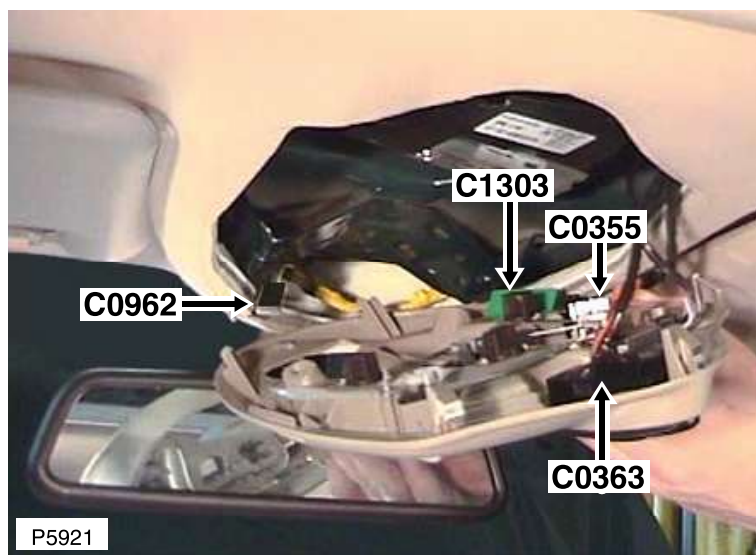
Description: *Microphone - Telephone*

Location: *Behind interior light*

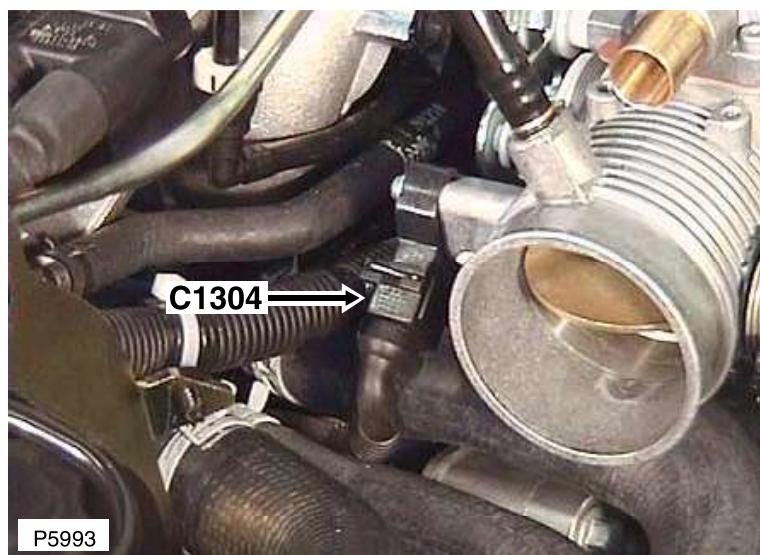
Description: *Sensor - Traction control - KV6*

Location: *Above gearbox*
