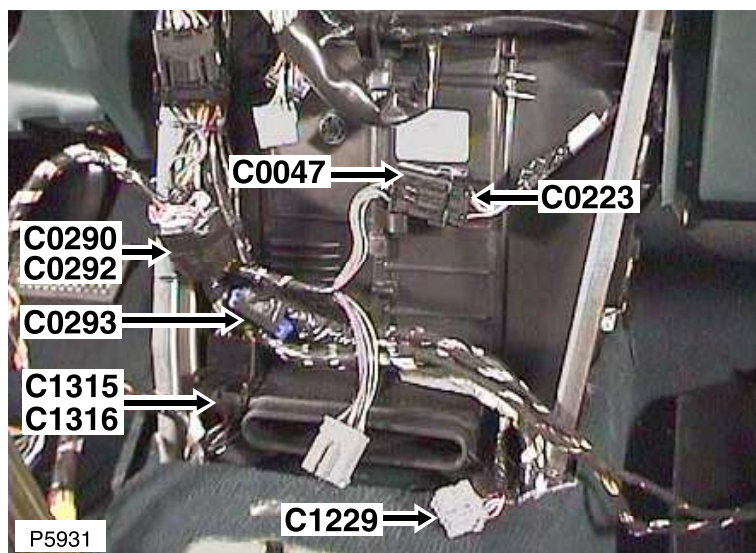
Description: *Radio / cassette player*

Location: *Behind front of centre console*

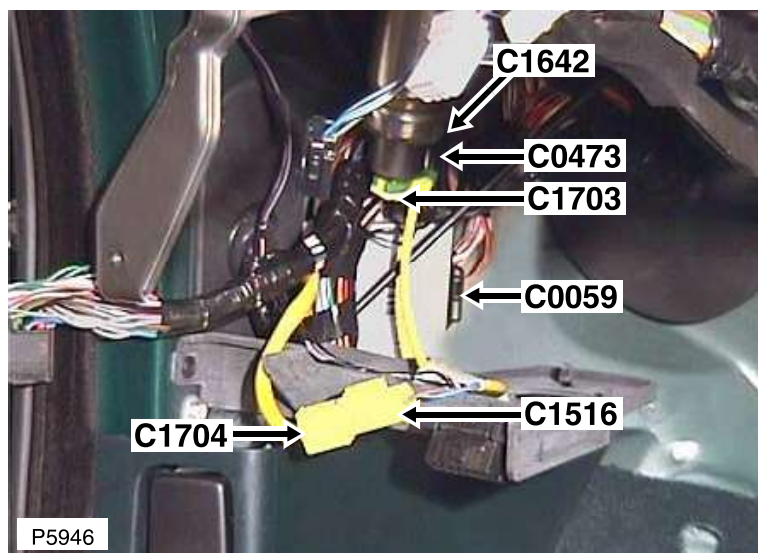
| Cav | Col | Cct |
| 1 | Y | ALL |
| 2 | R | ALL |

Description: *Main harness to SRS harness*

Location: *Behind LH side of fascia*

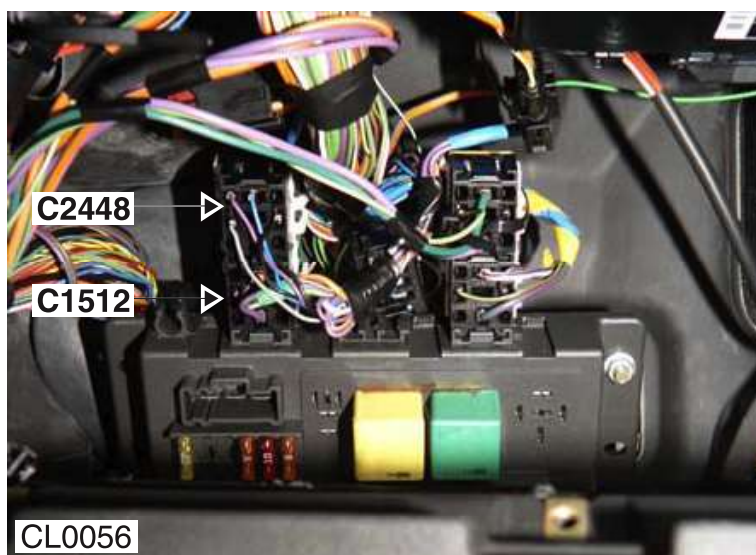
| Cav | Col | Cct |
| 2 | OR | ALL |
| 4 | U | ALL |
| 5 | LGW | ALL |
| 6 | BY | ALL |
| 8 | P | ALL |

Description: *Relay - FBH*

Location: *Behind Glovebox*

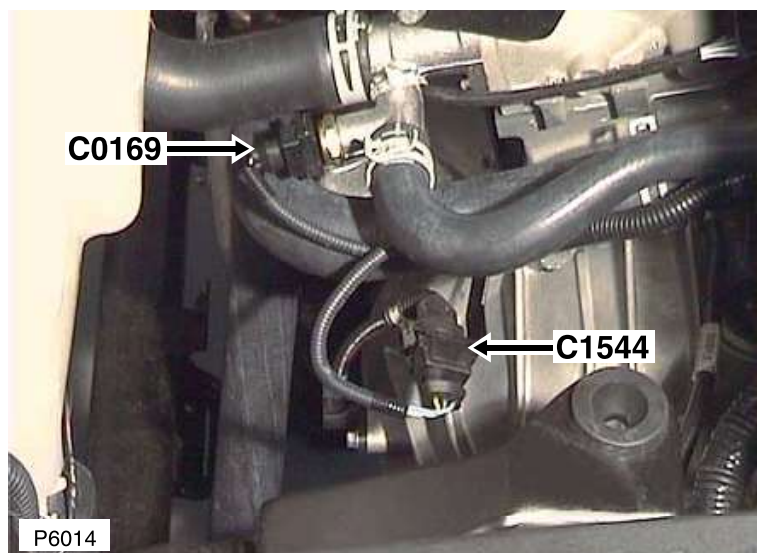
| Cav | Col | Cct |
| 1 | YU | ALL |
| 2 | UP | ALL |
| 3 | WU | ALL |

Description: *Sensor - Crankshaft position (CKP) - K1.8*  
Location: *Front of engine - centre*

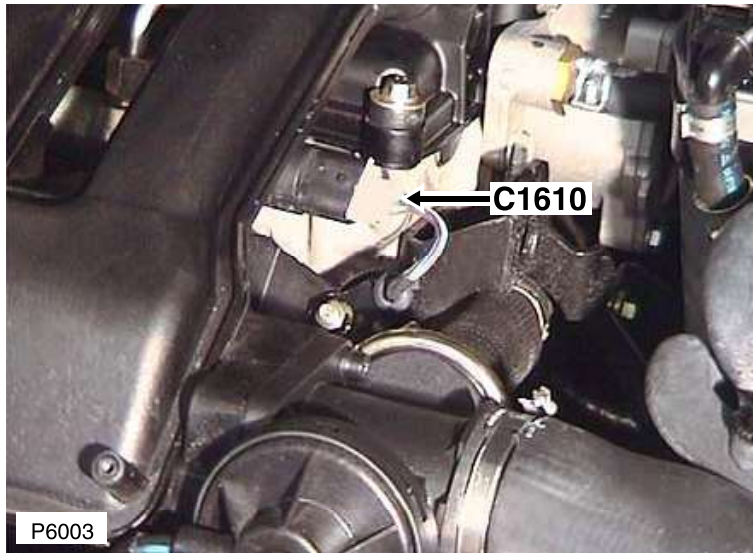
Description: *Sensor - Pressure - Fuel rail - M47R*

Location: *Rear of engine compartment*

| Cav | Col | Cct |
| 1 | NG | ALL |
| 2 | UB | ALL |
| 3 | WY | ALL |

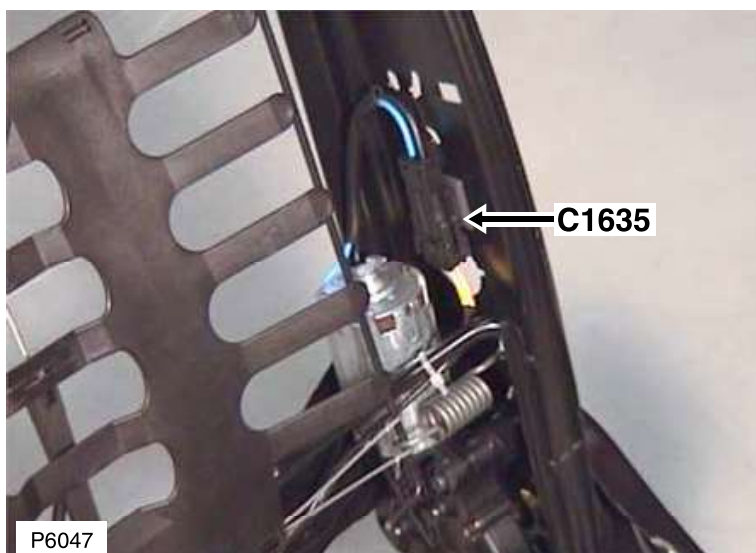
Description: *Motor - Seat - Back recline - RH*

Location: *Under front seat squab cover*

| Cav | Col | Cct |
| 1 | KY | 14 |
| 2 | KU | 14 |
| 3 | RG | 14 |
| 4 | BG | 14 |
| 5 | YK | 14 |

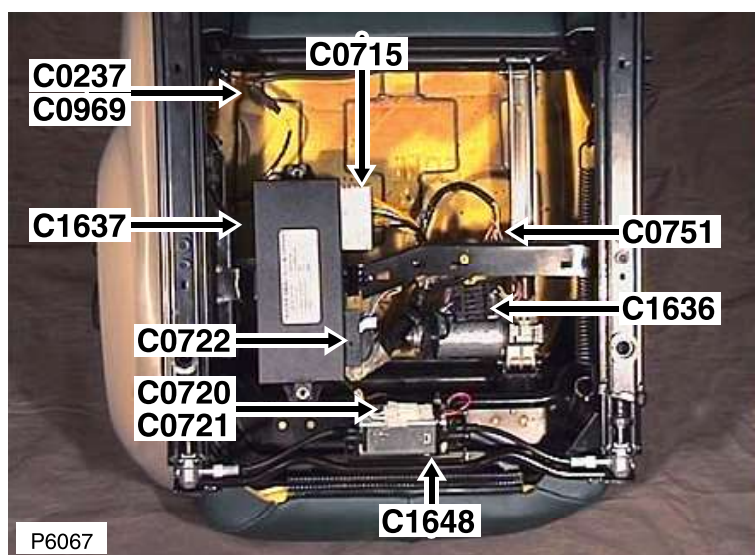
Description: *Motor - Seat rear - Up / down*

Location: *Beneath driver's seat*

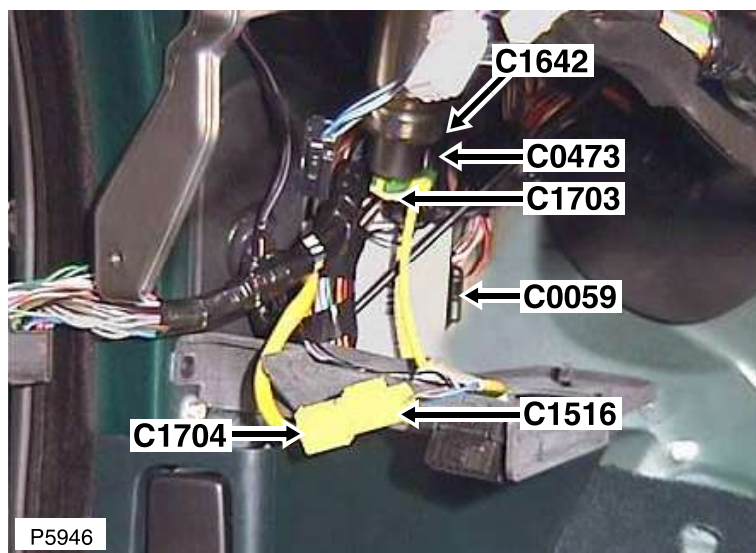
| Cav | Col | Cct |
| 1 | OS | ALL |

Description: *Main harness to trailer harness*

Location: *Behind LH side of fascia*

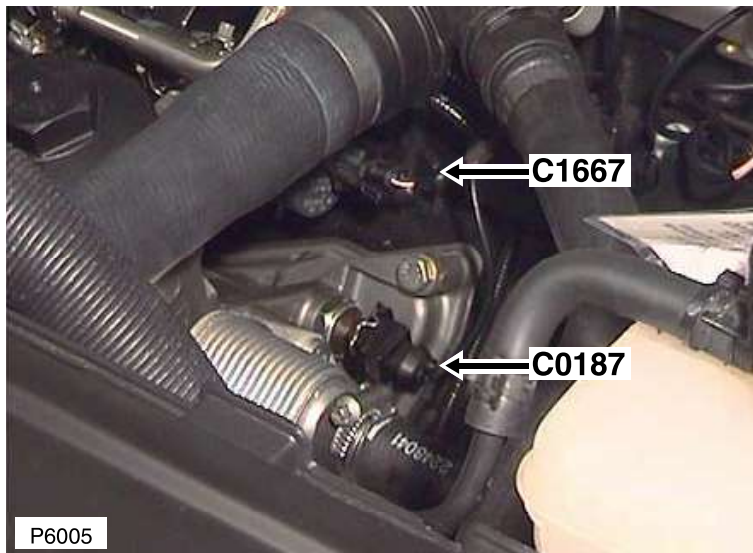
| Cav | Col | Cct |
| 1 | RW | ALL |
| 2 | NU | ALL |

Description: *Regulator - Fuel pressure - M47R*

Location: *Front of engine - centre*

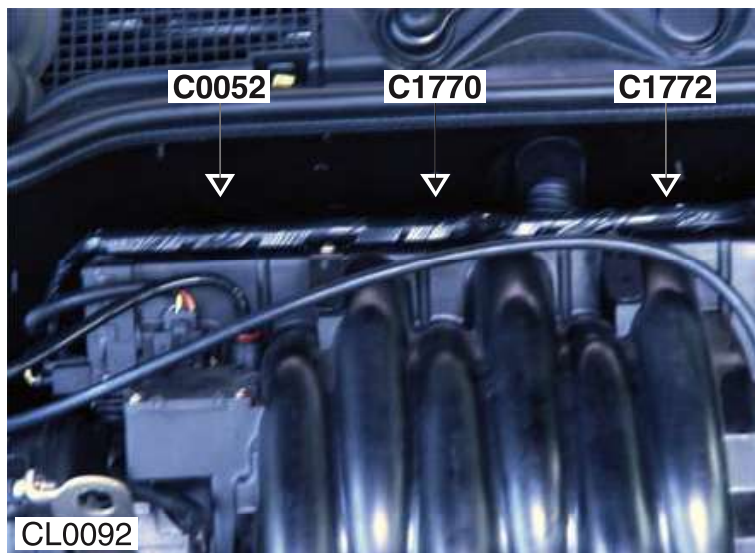
Description: *Ignition coil - 4 - KV6 - Plug top coil*  
Location: *Top rear of engine - centre*

| Cav | Col | Cct |
| 1 | NK | ALL |
| 2 | B | ALL |
| 3 | BY | ALL |

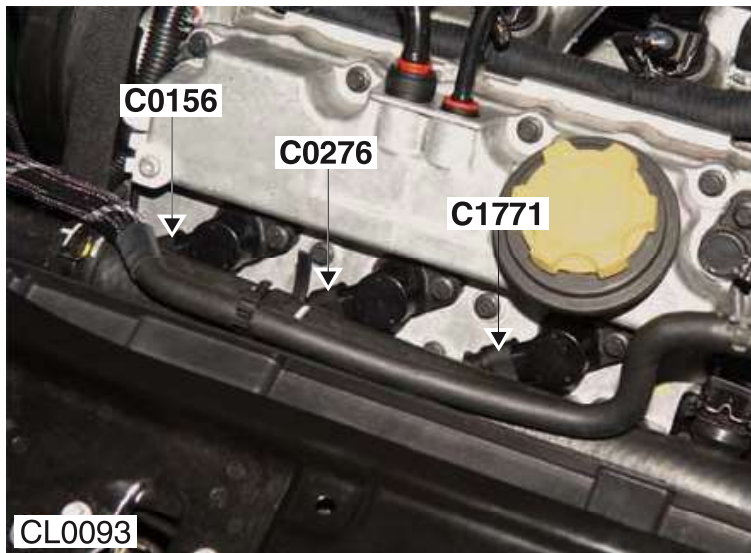
| Cav | Col | Cct |
| 1 | NK | ALL |
| 2 | B | ALL |
| 3 | BP | ALL |

Description: *Ignition coil - 5 - KV6 - Plug top coil*

Location: *Top front of engine - right*

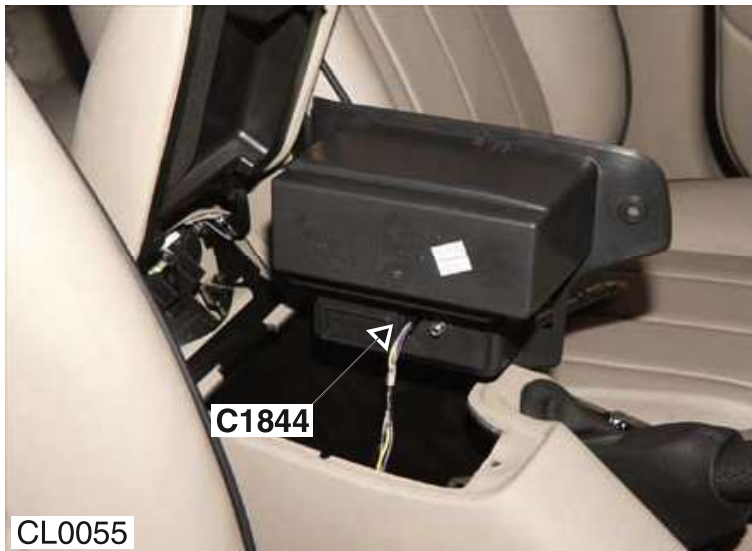
Description: *Timer - FBH*

Location: *Inside cubby box*

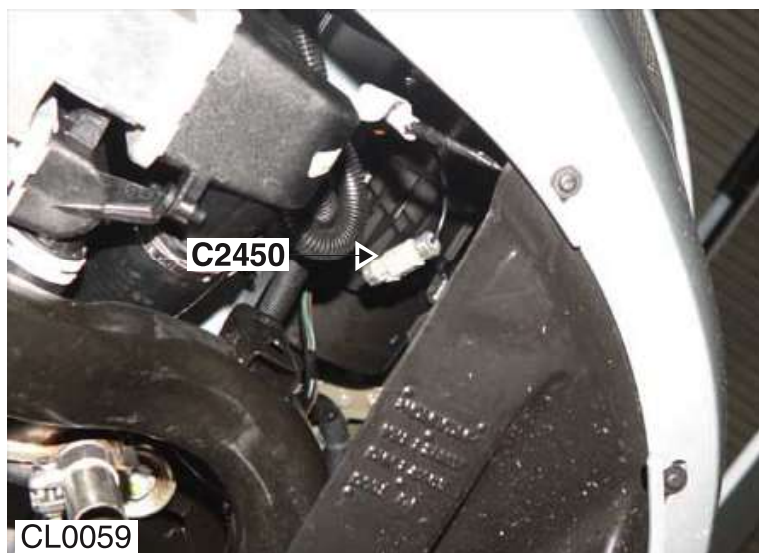
| Cav | Col | Cct |
| 1 | B | ALL |
| 2 | SCR | ALL |

Description: *Receiver - FBH*

Location: *Behind front bumper*

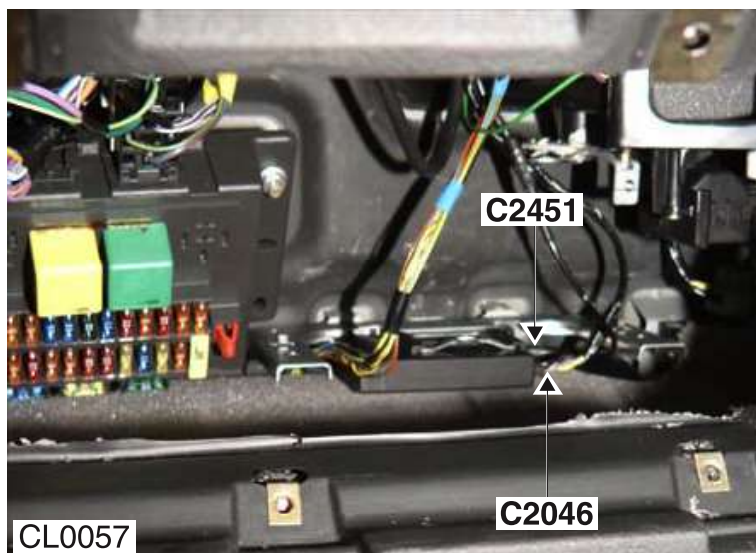
| Cav | Col | Cct |
| 1 | B | ALL |

Description: *Receiver - FBH*

Location: *Behind Glovebox*
